Air Conditioner Controller Servicing (non-USA type) for RHD.

The problem – Aircon always set itself to lowest temperature

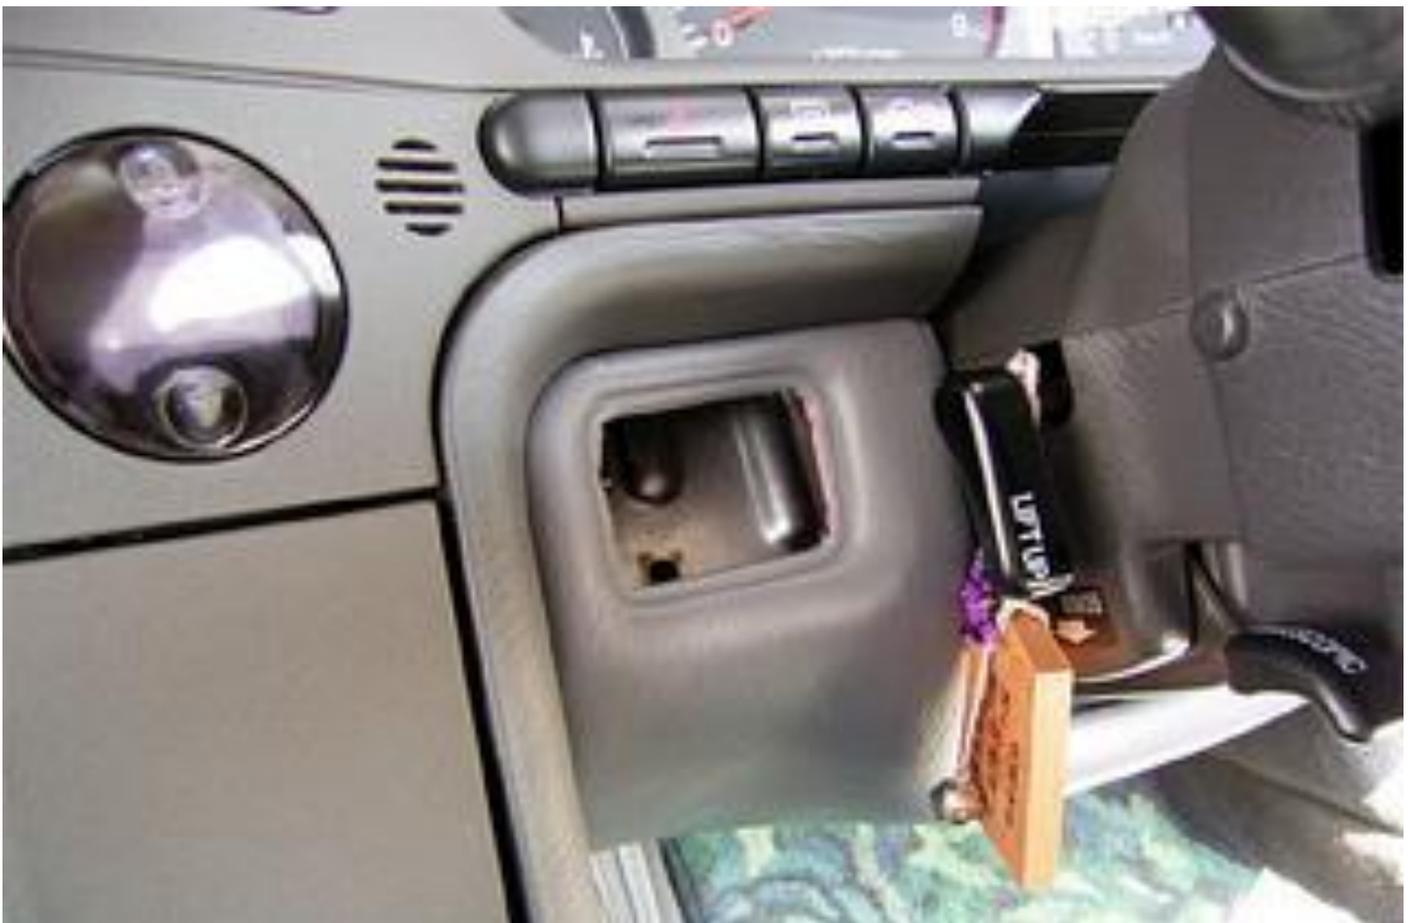
Remove Coin holder and also remove the bolt that is now exposed.

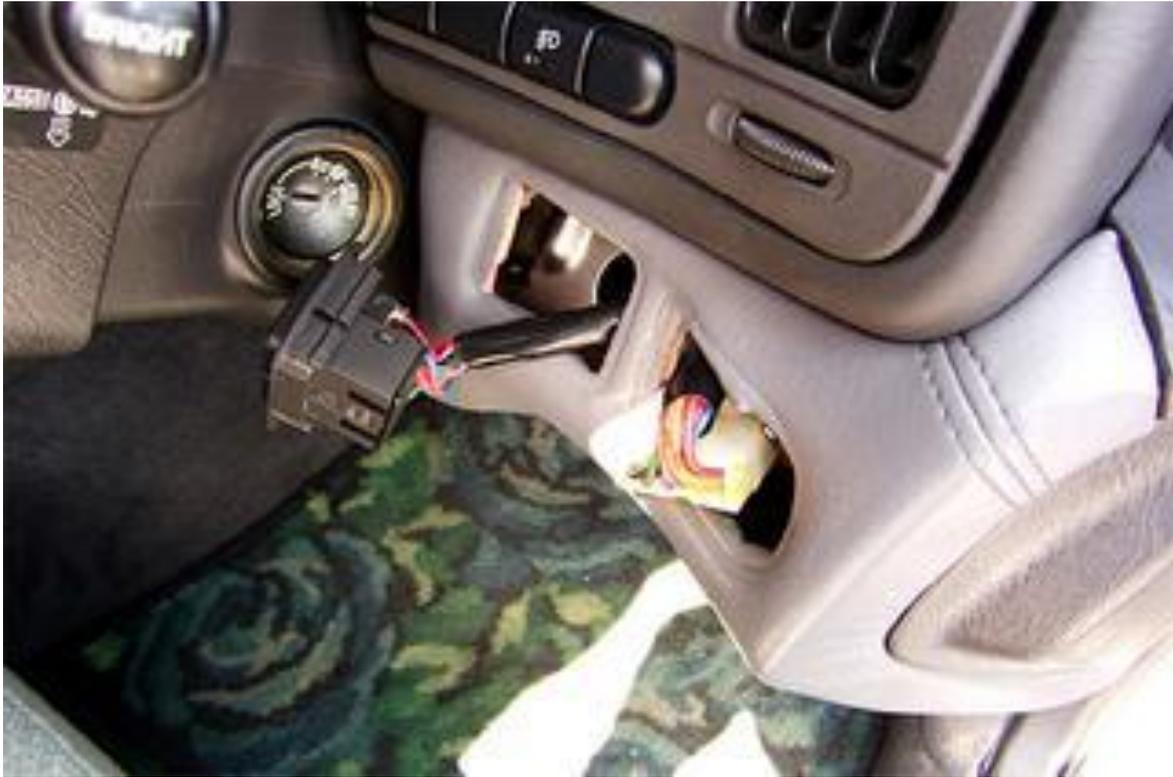
Pull forward both sets of switches (Park and Mirrors) and remove them from joining connectors (if you cannot do it at this stage then leave till later on – it is easier to do as you remove more pieces).

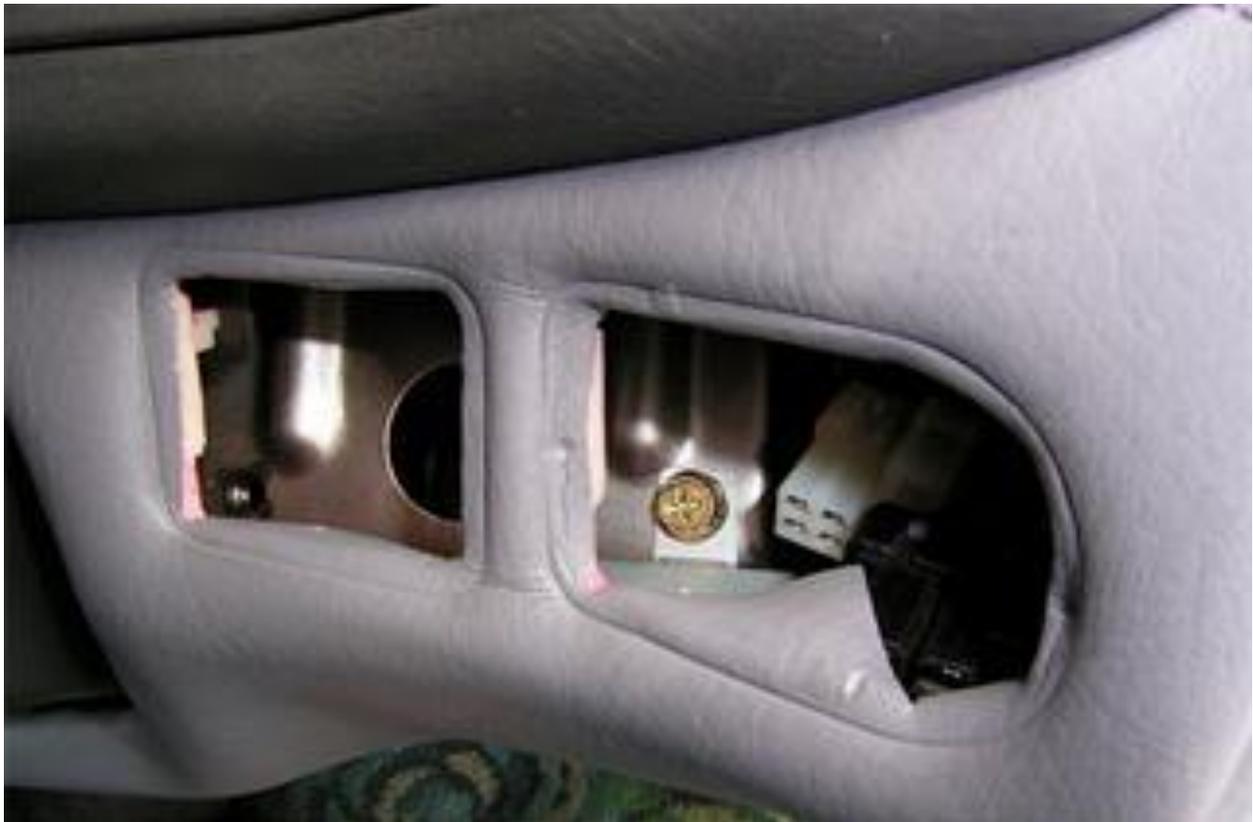
Remove the bolt that is exposed behind switches.

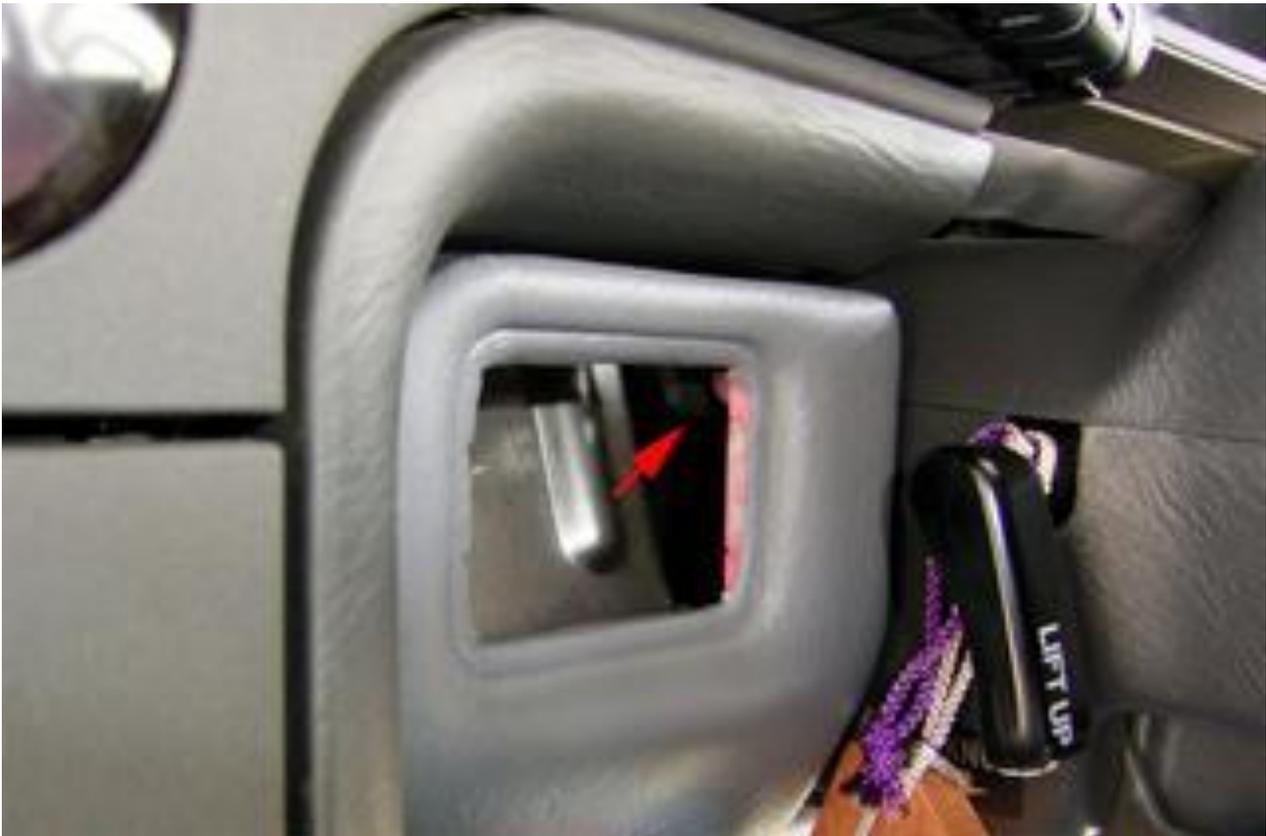
Get a mirror to see clip shape and position behind panel; place finger behind the opening and pull slightly upwards to unclip. NB: the clip is part of the fibreglass shell, do not break it!

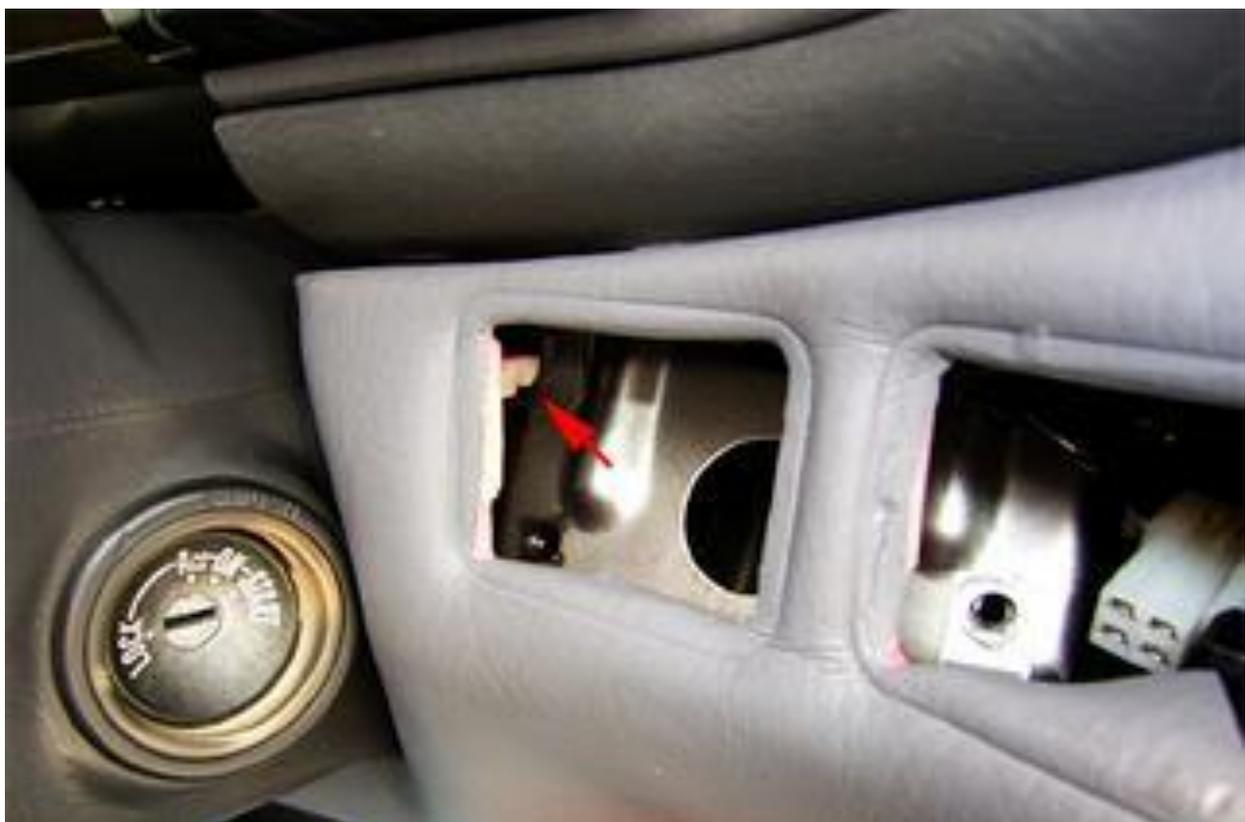
And again unclip from other side of steering wheel.

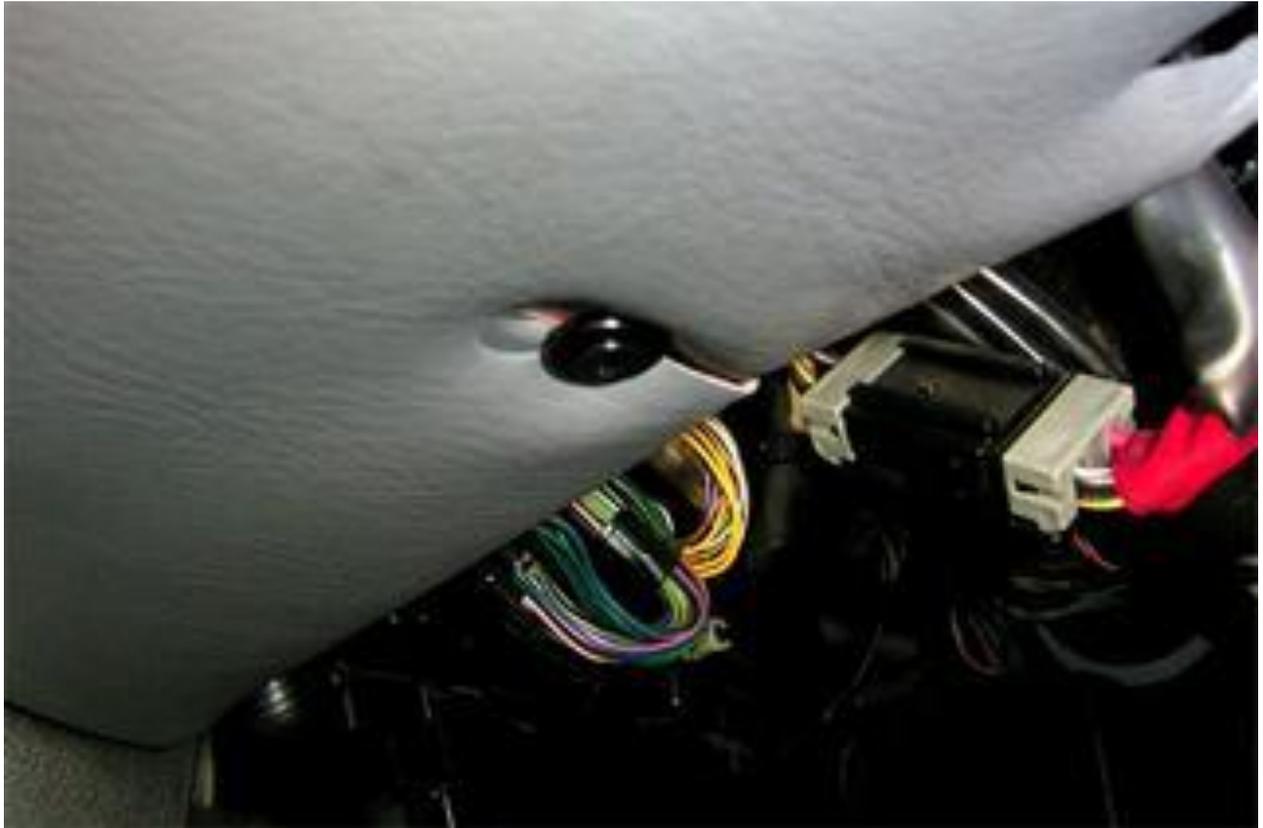
Under steering rack cover near 'Winter/Summer wipers switch' there is a small plastic screw that needs to be removed.

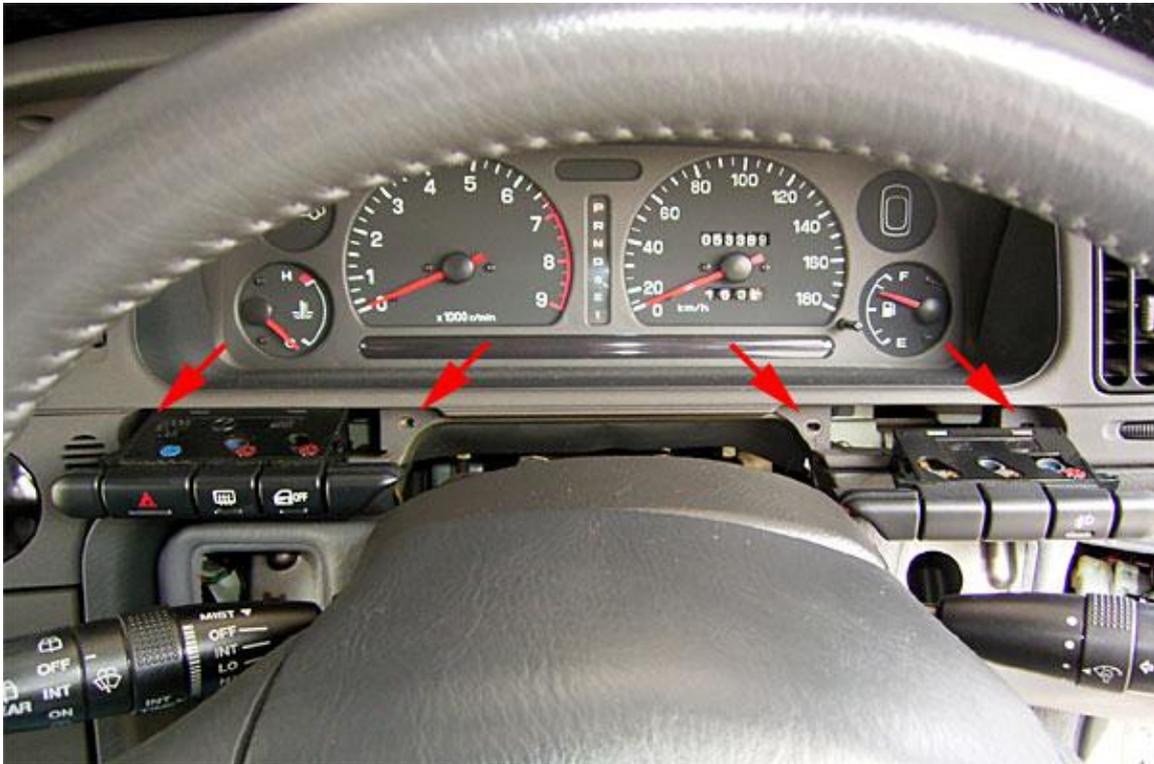
Next, slide fingers into the openings below the switch clusters and gently pull the switches forward.

Rotate switches in towards the steering wheel and slide into the bezel slots, this exposes 4 instrument surround screws – remove these.

NB: Depending on the wiring length sometimes the inner plastic pieces on each switch assembly (curved sections next to steering wheel) need to be removed before switches can be fully rotated inwards.

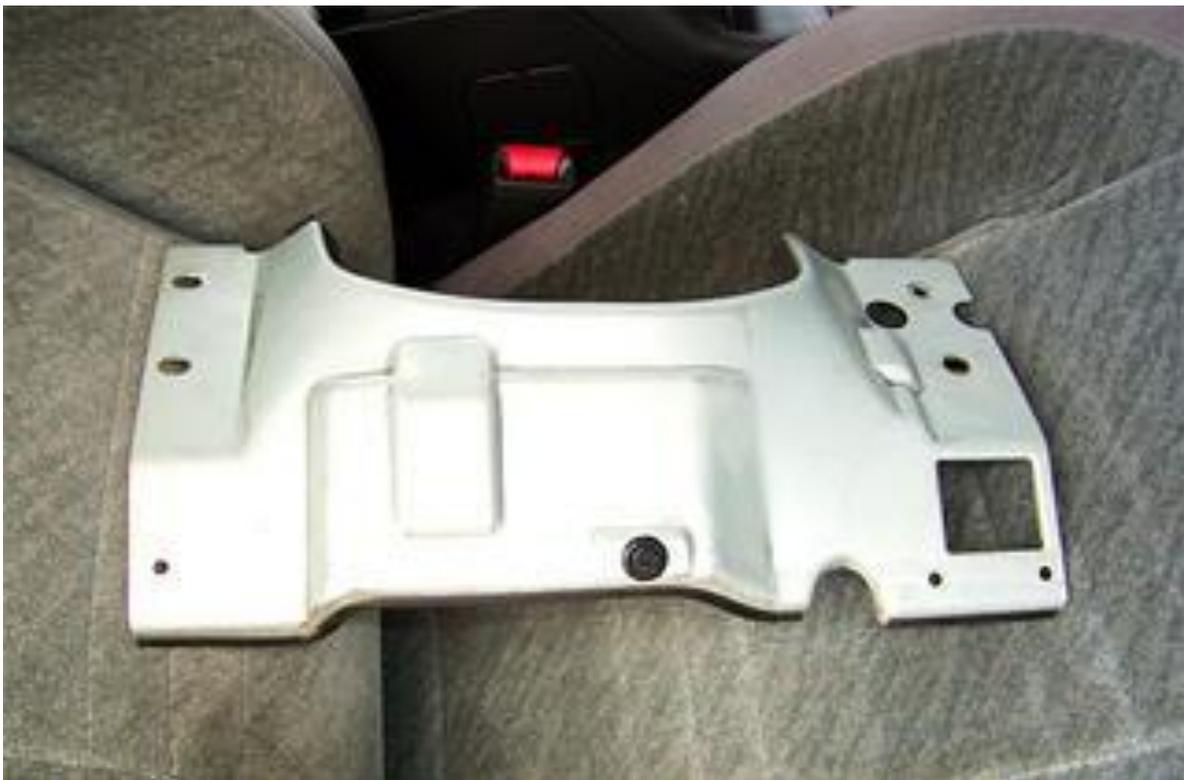
Under the steering rack you now have a metal cover plate – remove this.

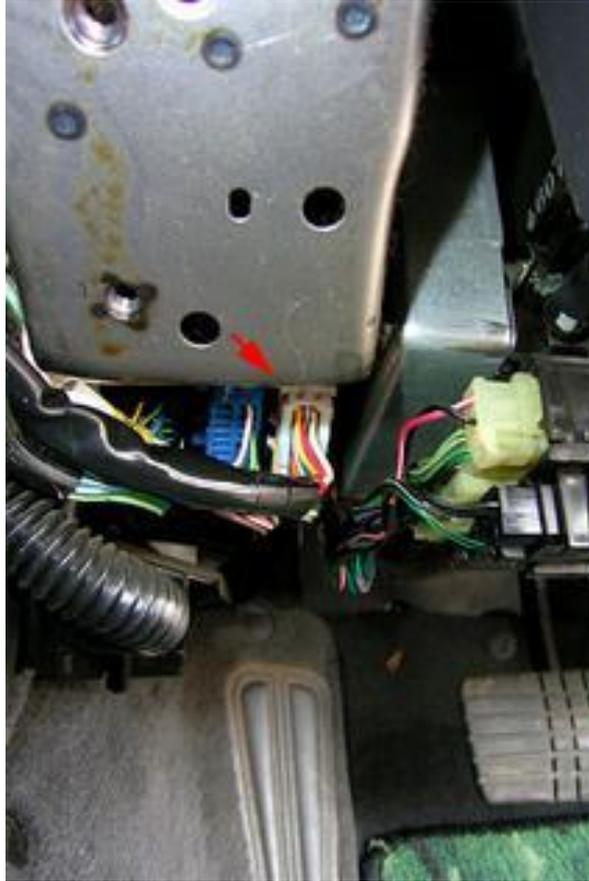
- LHS switch harness connector.

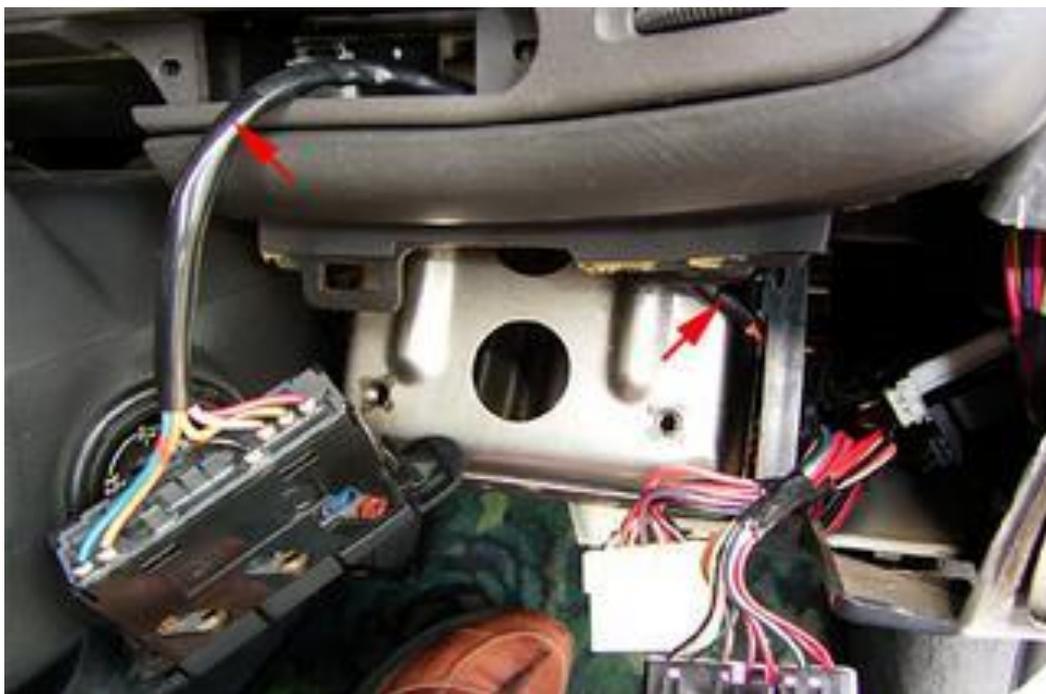
- RHS switch harness connector.

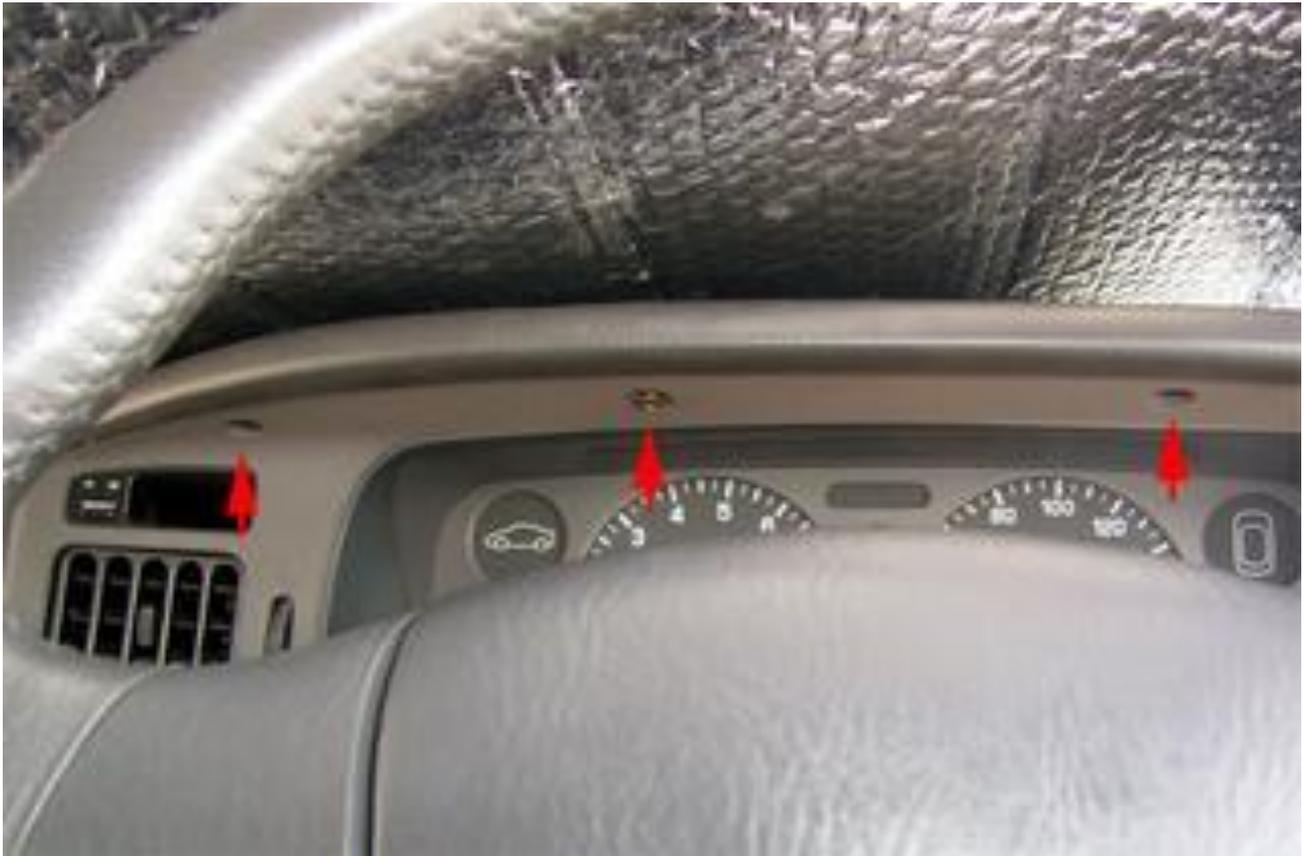
Remove the 3 upper screws from under the instrument cluster.

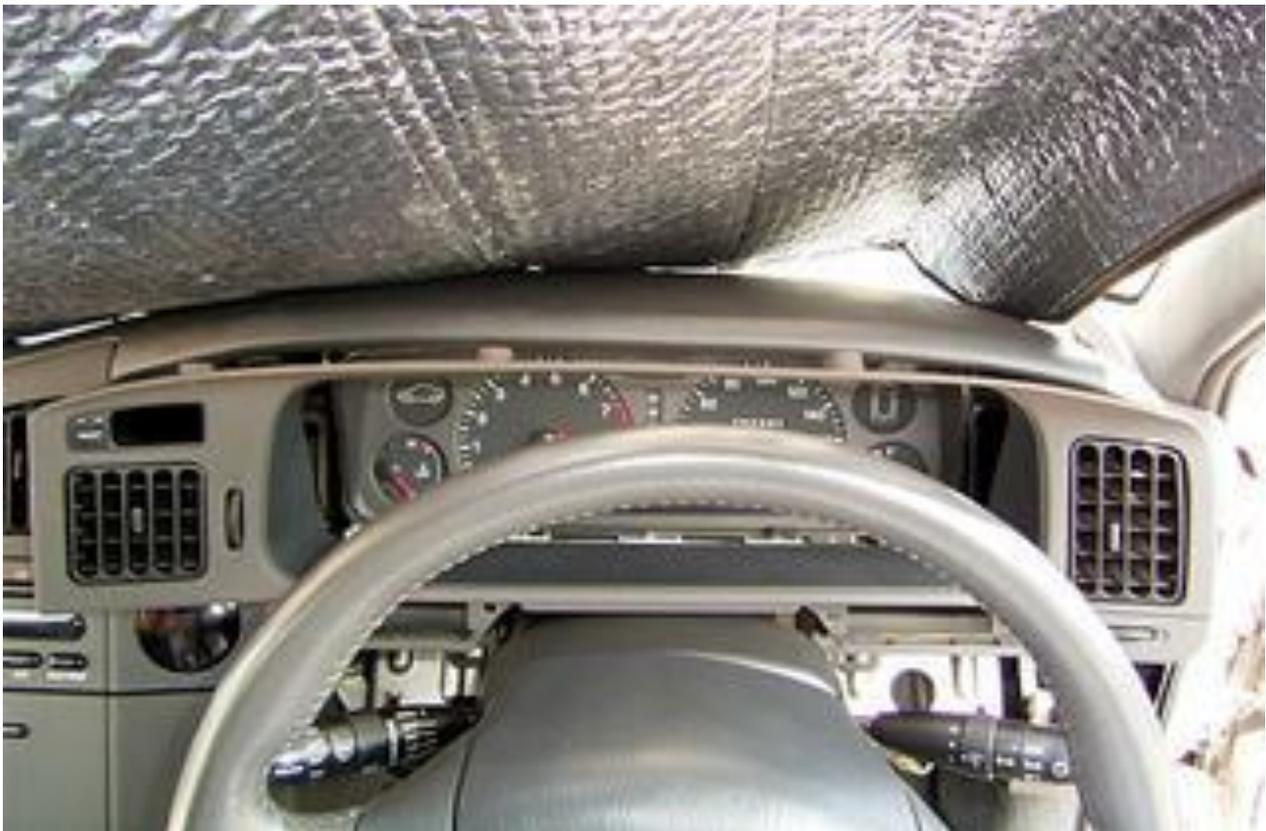
Pull the cluster surround forward, rest on steering rack cover while you unclip wiring connector from the clock.

Bottom Right arrow shows clock connector.

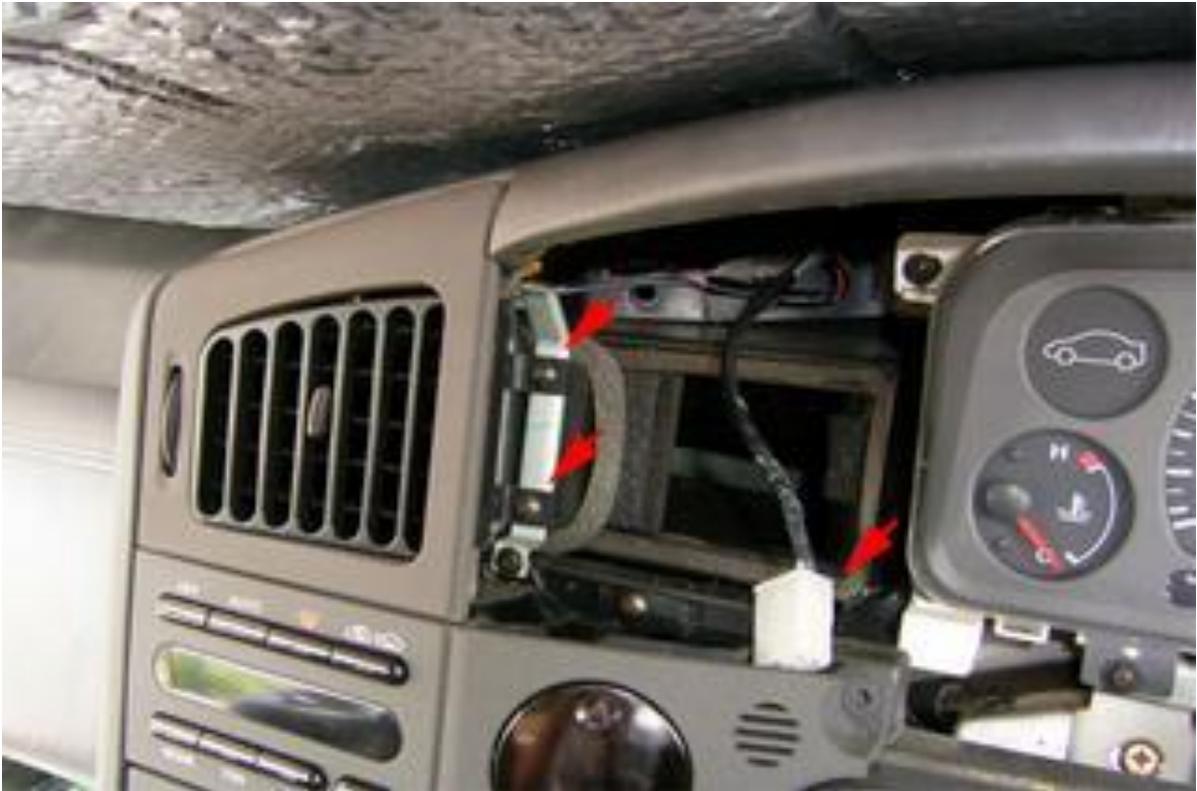
Undo the screws arrowed and pull the vent forward. Be careful as the vent has a small clip (see 2 pictures below) in the bottom LH corner that holds on to the top of the A/C controller (below thumb wheel), this is easily broken if not done carefully - you might see it with a mirror before you attempt to remove this.

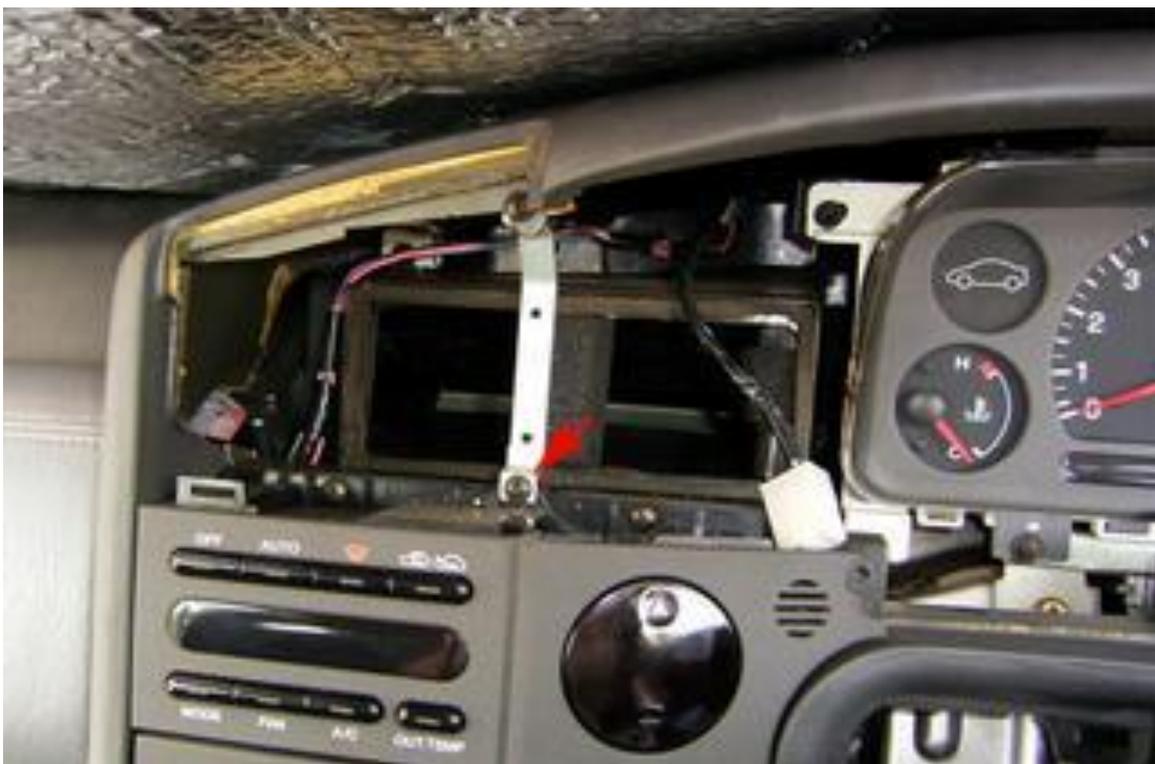
Now you can see the clip opening at top RH corner of A/C controller.

Remove the screw and swing the metal bracket to the right.

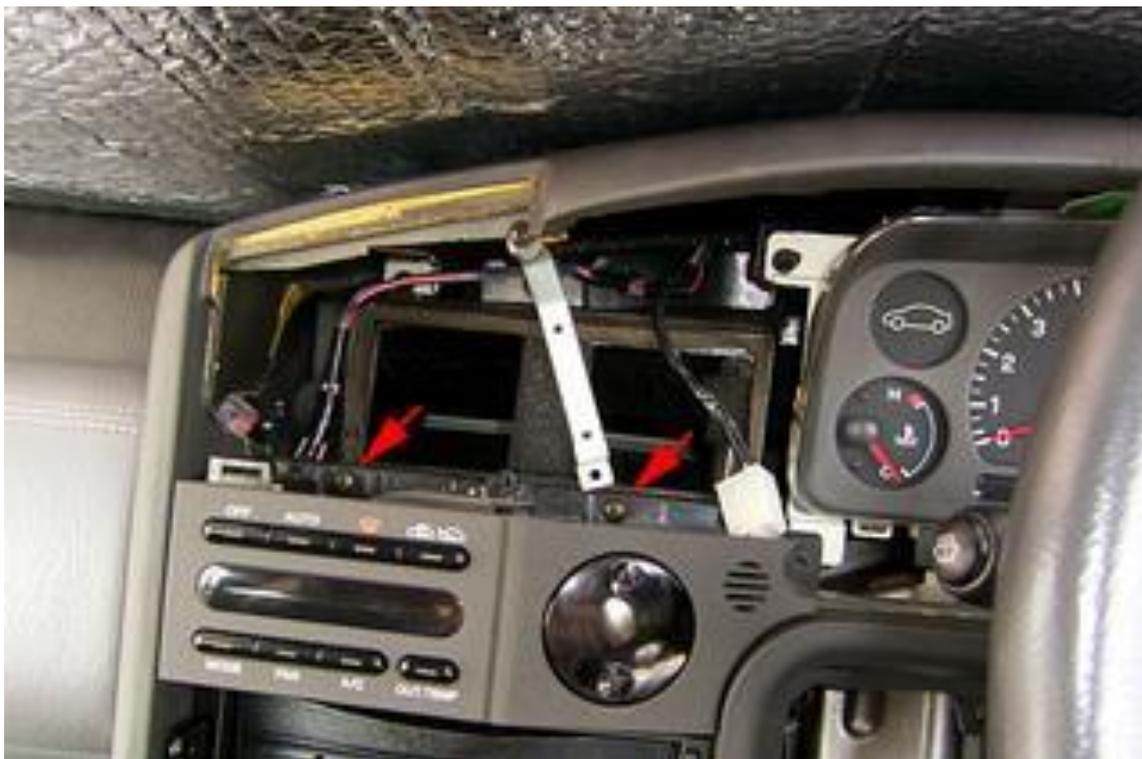
Remove the 2 screws on top as indicated.

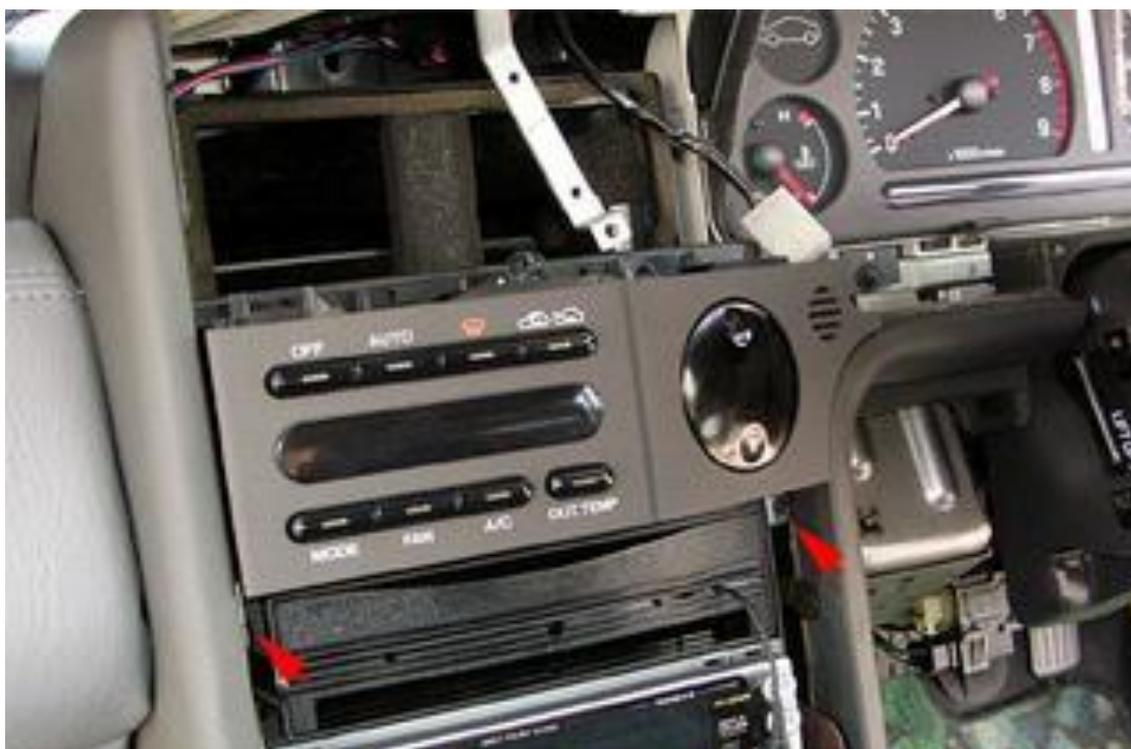
Remove the 2 screws under the A/C Controller (arrowed)

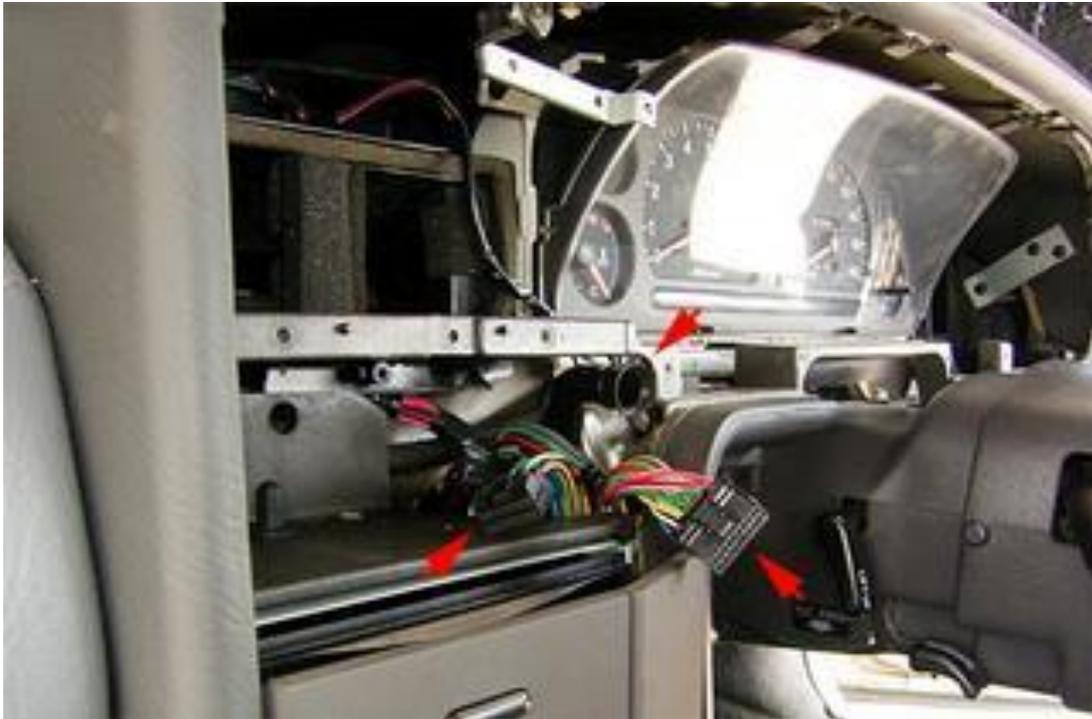
Pull unit out at an angle: all the wiring harness connectors are towards steering wheel side so pull and swivel towards steering wheel.

Once out there are 2 wiring harness connectors and a plastic air pipe (used for the thermistor cabin temperature sensing).

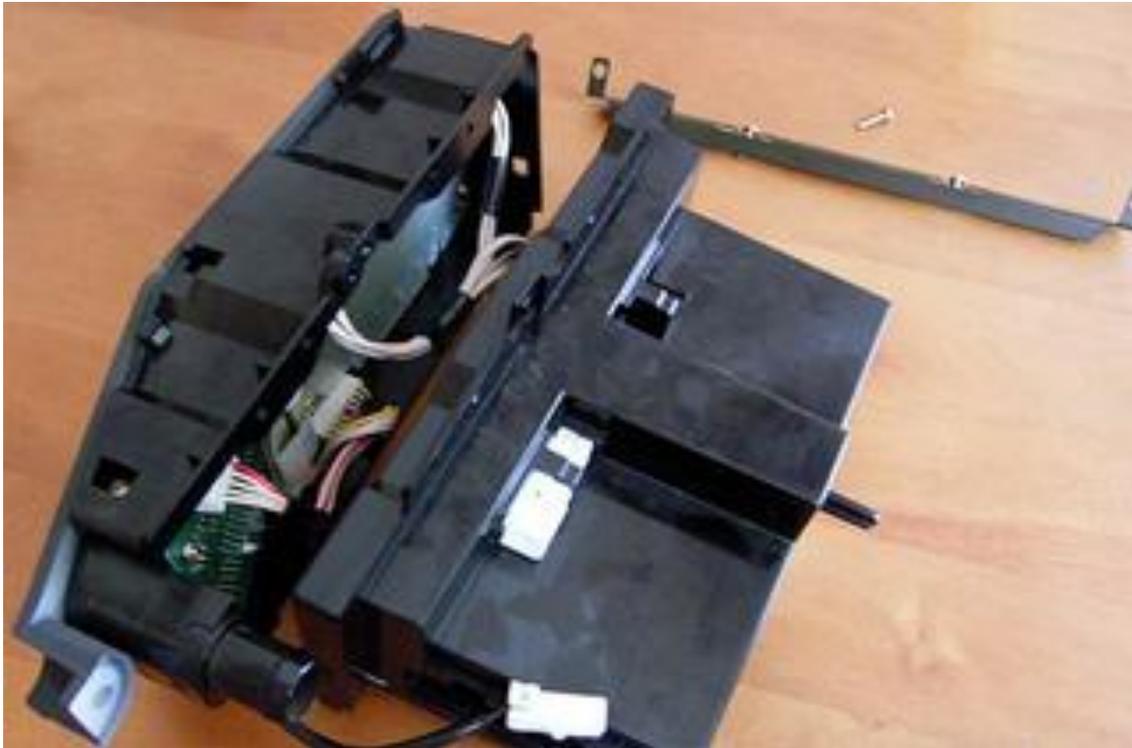
Remove the 2 screws that hold the mounting bar under the unit.

Disconnect the wiring harness that runs to the white connector on top.

Then remove all the screws that you can see, note that the case is still held together by 2 small clips (one at each end).

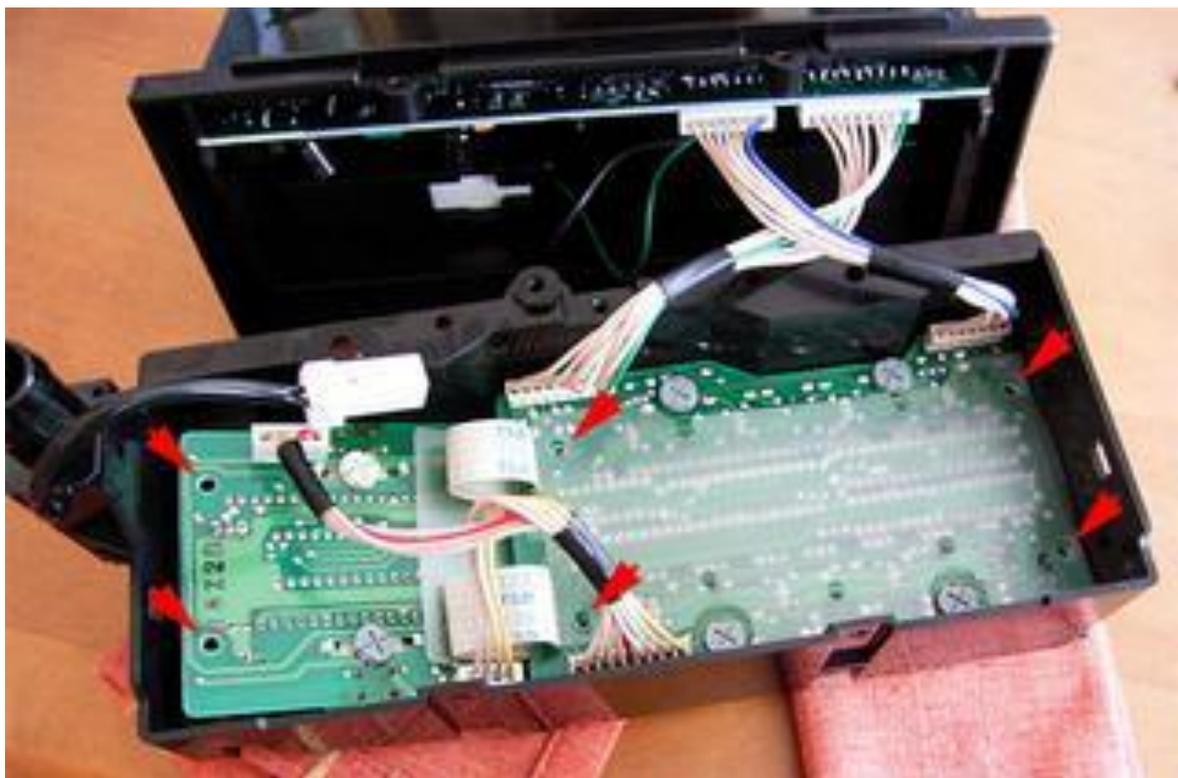
Once the unit is open, remove the 6 screws shown.

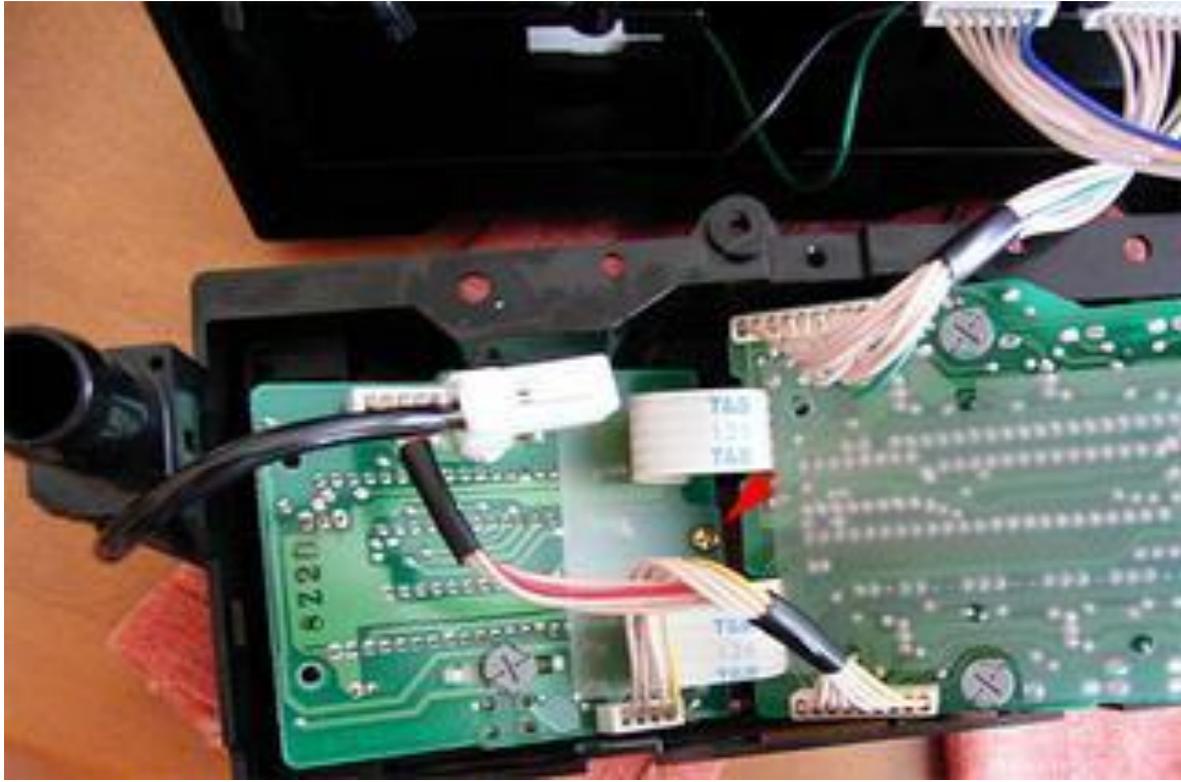
Remove the single screw in the middle.

Also at this stage unplug the wiring connectors (2) that are shown at top RH corner of this photo e.g. on the non-display PCB.

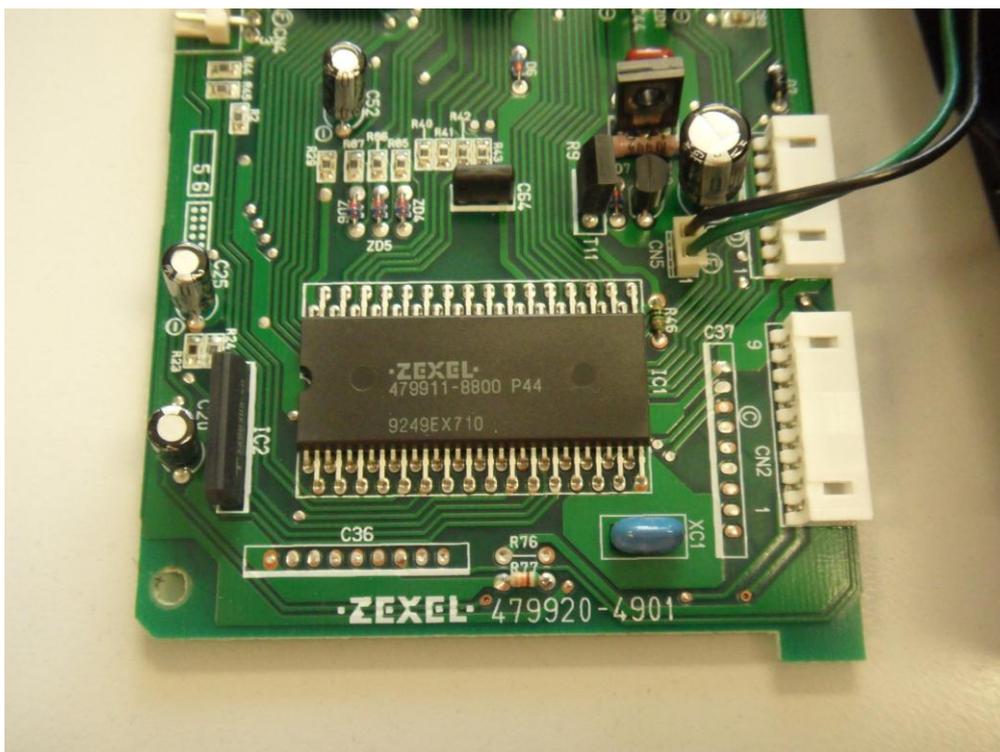
Here are the 2 white connectors without wiring harness (there is no reason to take rear PCB out of case –only shown for reference).

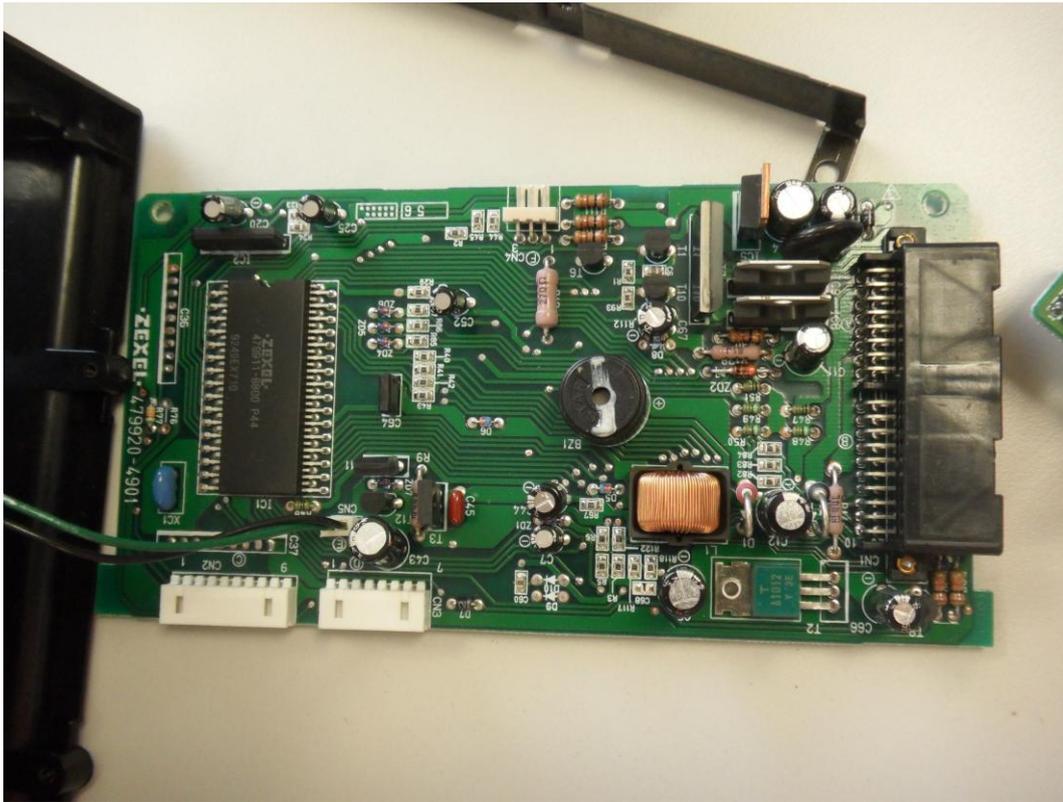
Another shot showing white connectors

I suspect that Zexel subcontracted out the 2 PCBs to 2 different manufacturers – the unit above shows Rubycon capacitors (high quality), whereas the capacitors on the display PCBs are a no-name brand.

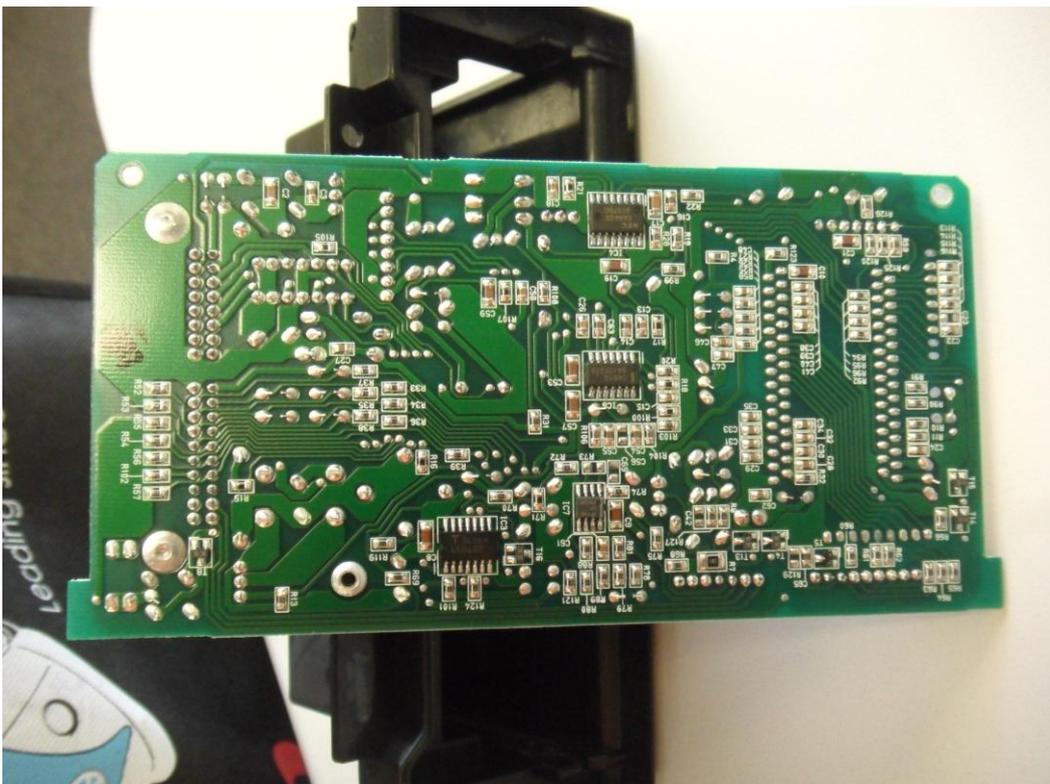
Another shot of non-display PCB showing the use of Surface Mounted Devices (SMD) also on the reverse side.

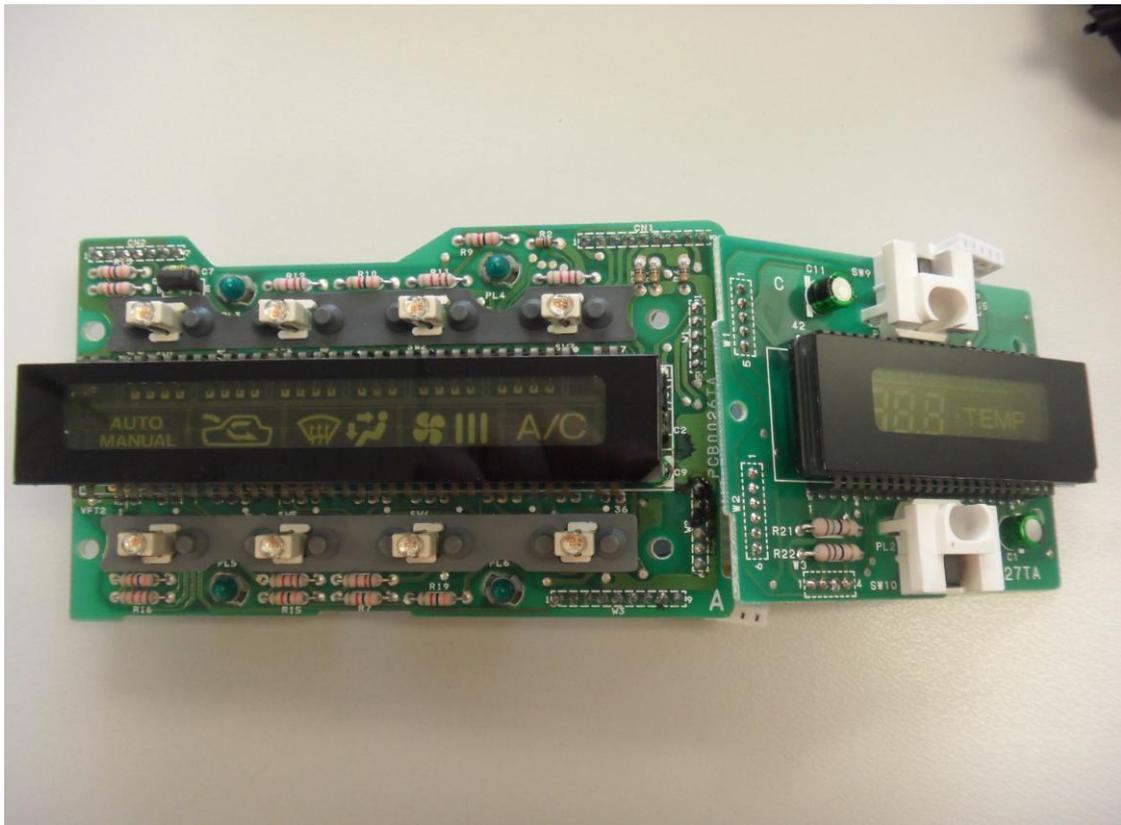
Now to the Display PCB assembly, spot the issue? See the letter 'A' at bottom RH corner of larger PCB – now look just above it at the vertical row of solder joints (W2) – there is a dark area, looks like something burnt.
