Air Conditioner Controller Servicing (non-USA type) for RHD.

The problem – Aircon always set itself to lowest temperature

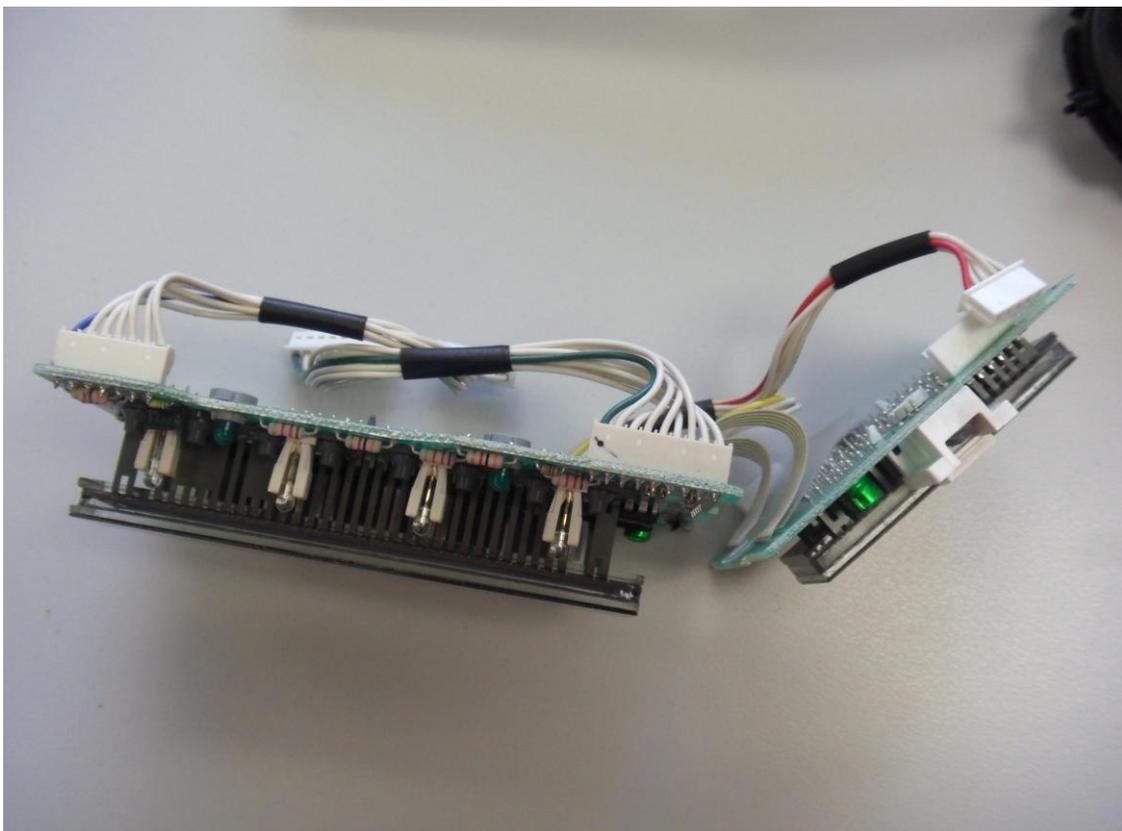
You will notice that there are 3 green capacitors in the assembly.

2 are on the up/down PCB – these are 25V rated and are normally ok.

But the one on the larger PCB is C9, and is only 22uF 16V and as such is prone to leaking due to voltage tolerance and also degrading due to the environment that the assembly is located in.

C9 should be changed to 22uF 25V.

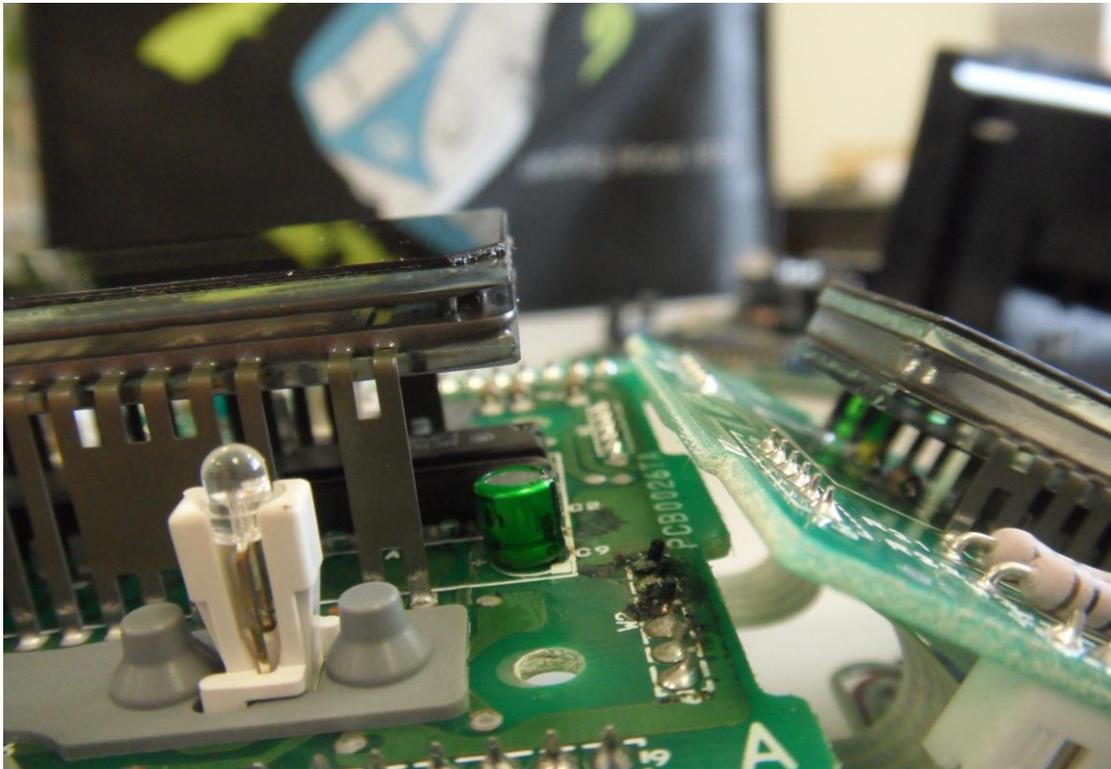
As you can see in the series of photos below the negative end of C9 has lifted slightly (due to bulging – leaking electrolytic material from within).

Carefully remove C9, use solder-wick or a de-soldering station (e.g. solder sucker).

The main issue is that C9 is actually connected across the power supply, and the available de-soldering areas that the legs are soldered to are actually floating pads (e.g. from rear side they are not connected to anything).

All the connections to GND and +VE supply are connected under the C9 body, so be very careful when removing that you do not damage or lift the copper under the C9 body.

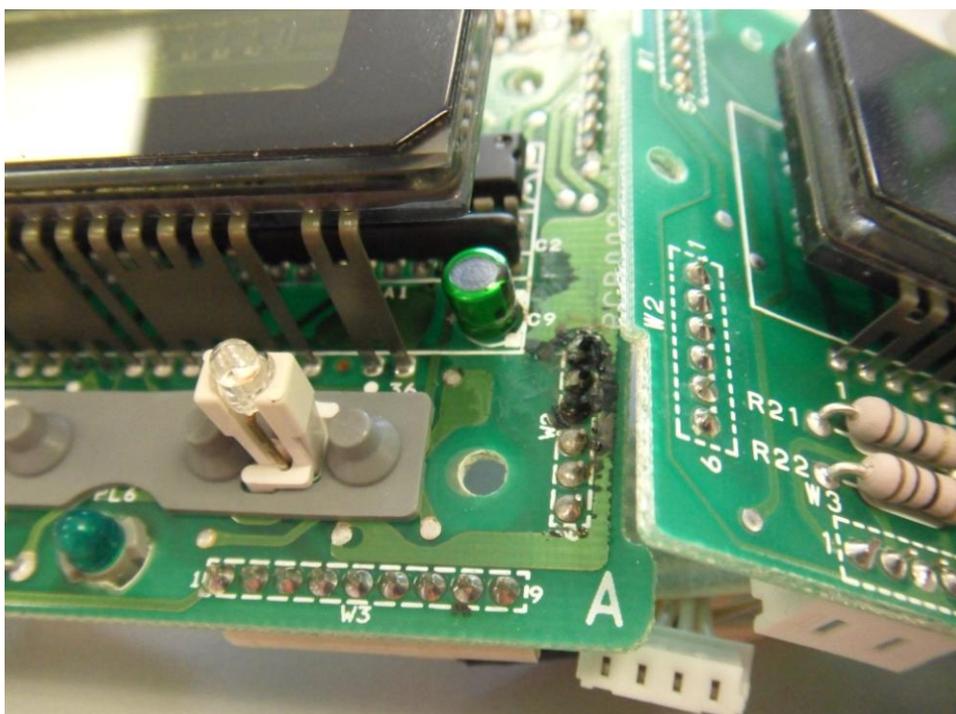
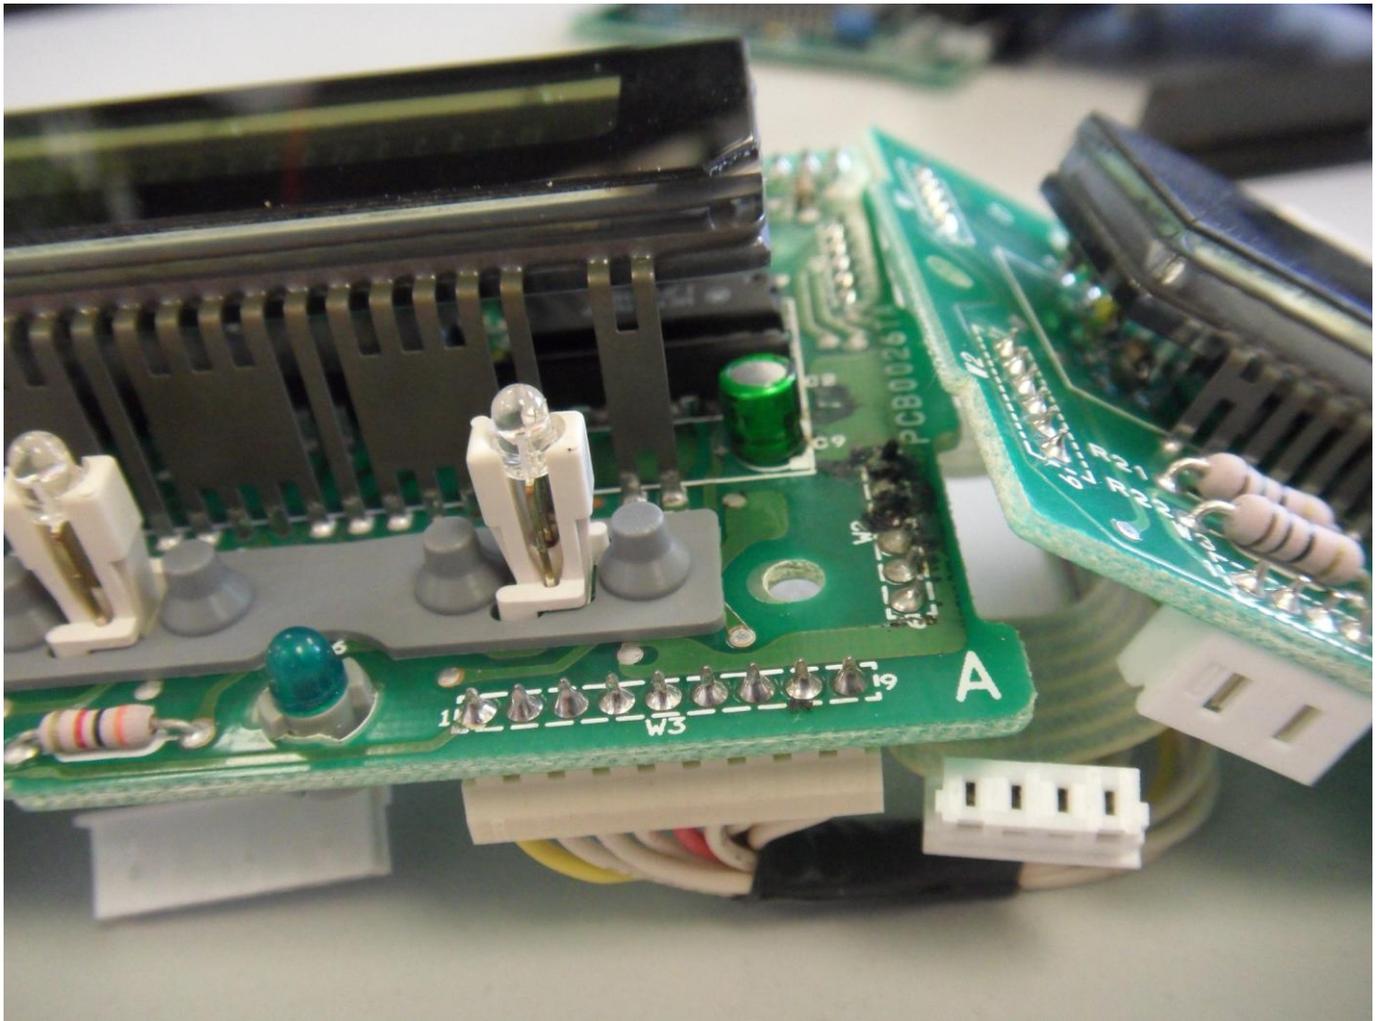
You can see discolouration of the green soldermask between letters C2 and C9 – this is corrosion from C9.

If you have a magnifier then check out the discolouration on the green solder mask covering – this shows where the liquid from the capacitor has eaten its way along the copper.

I would use either IPA or Ethanol to clean the circuit board after removal of the offending C9 part.

Also check the inductor next to C9 and the IC pin (all 3 units that I was fixing showed corrosion around these areas).

With a fine knife or tweezers you can carefully 'pick off' the corrosion before de-soldering (this way when you re-solder the new part, the surfaces will adhere correctly to both copper pads and C9 legs).

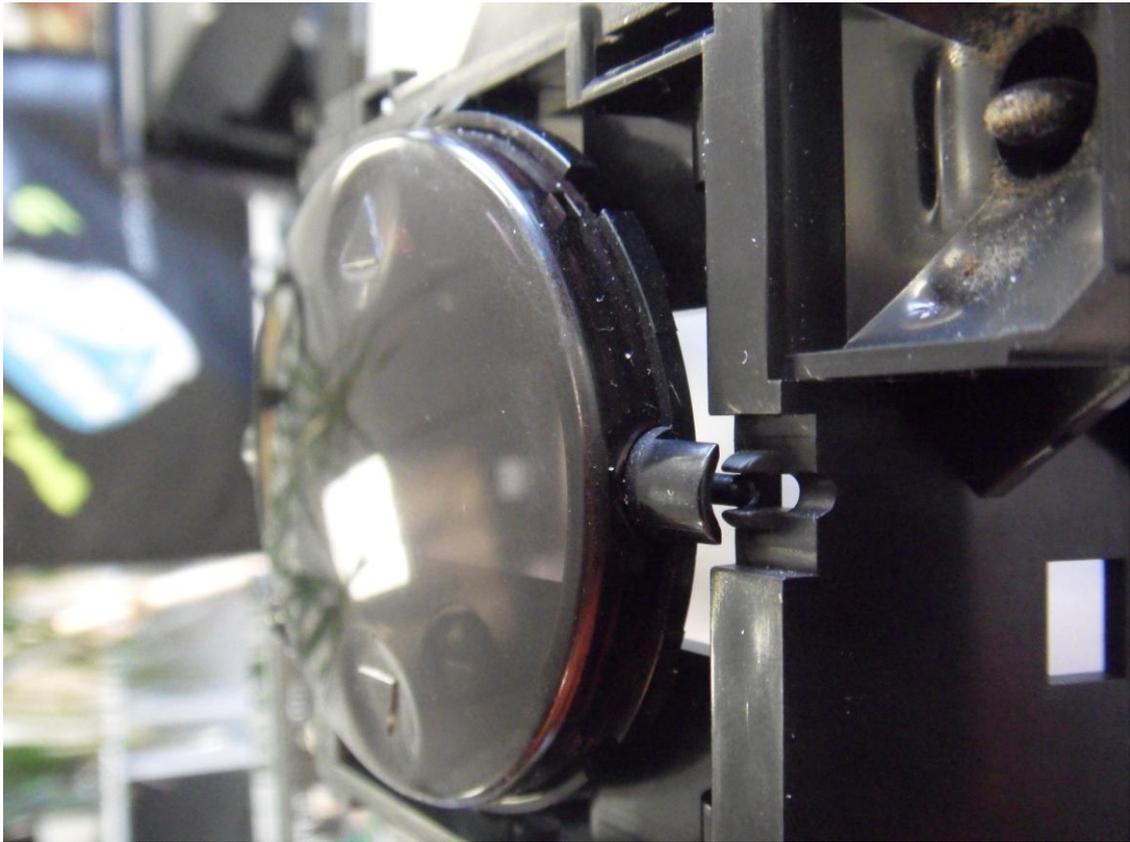
Another thing to check while the unit is apart is the up/down button, this simply pops off.

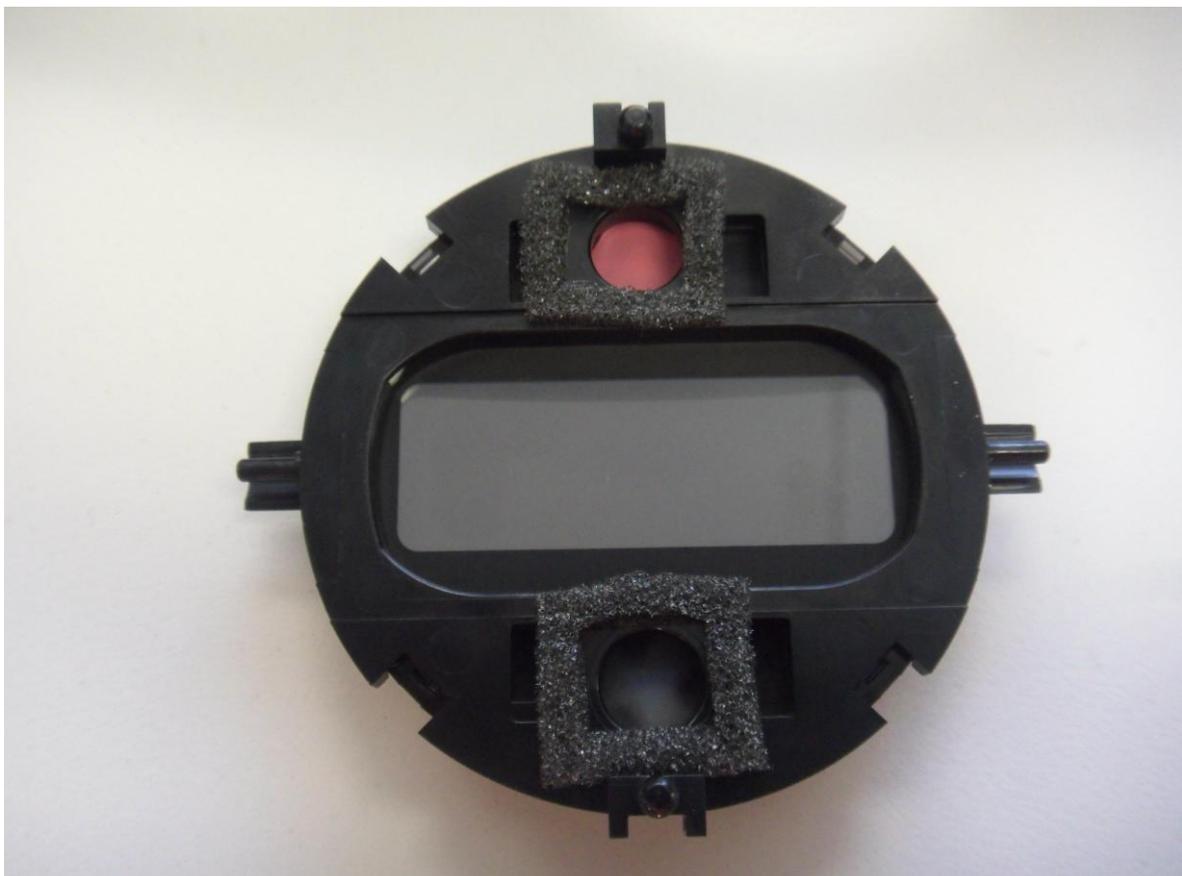
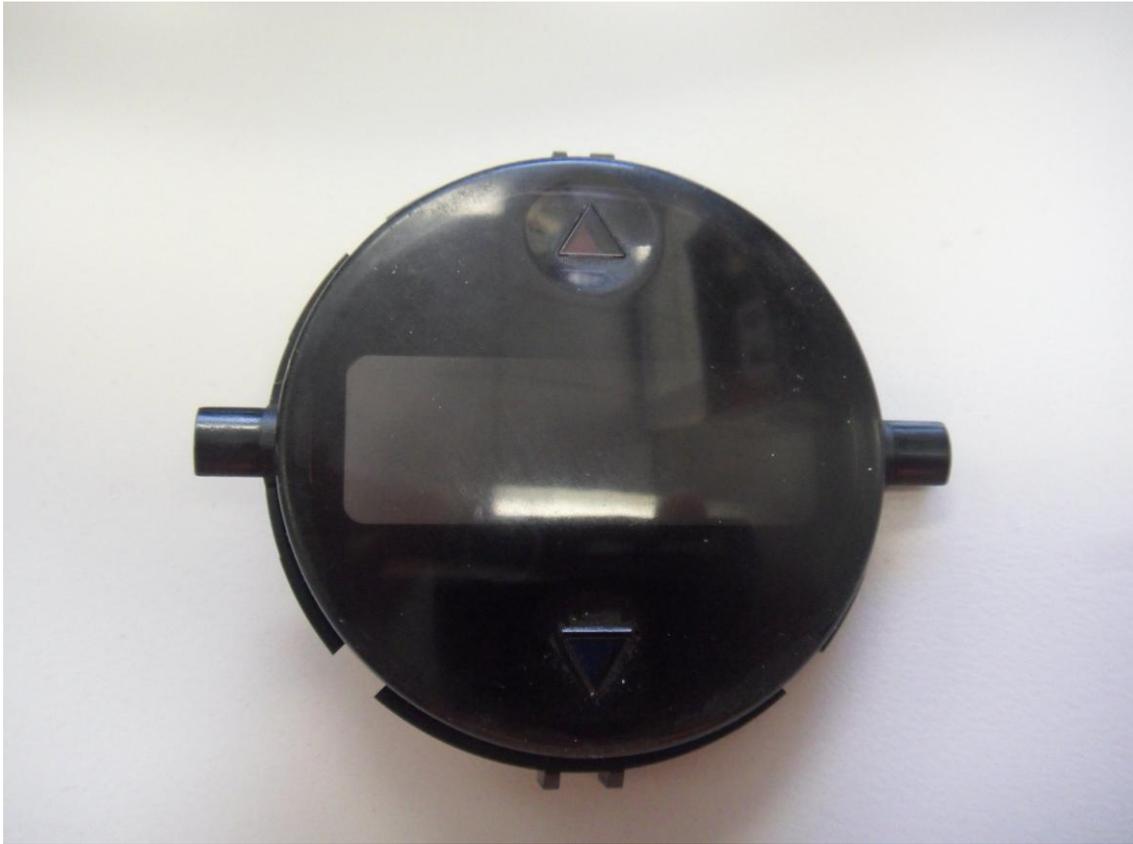
Check that all the foam tape is still in place and that there is no dirt or lint stuck behind (due to cleaning).

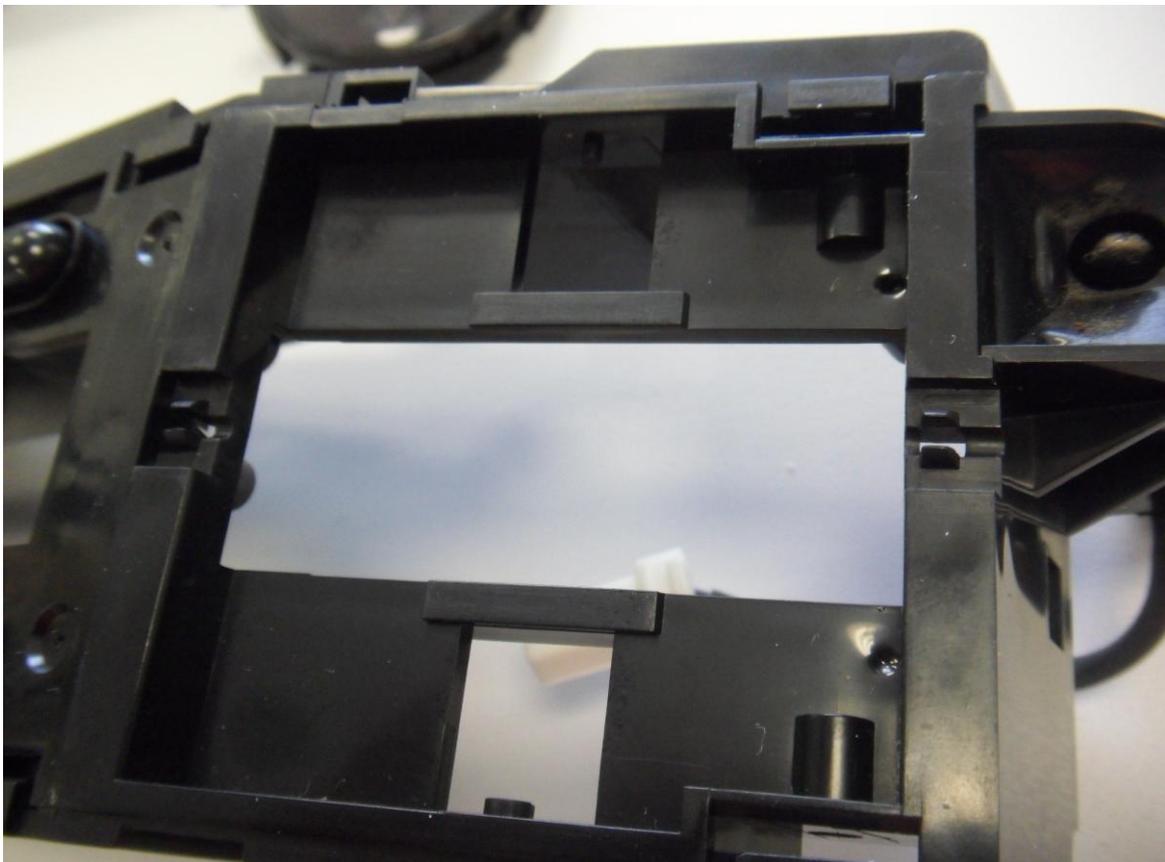
This shows the double hinge pivot area of the up/down button.

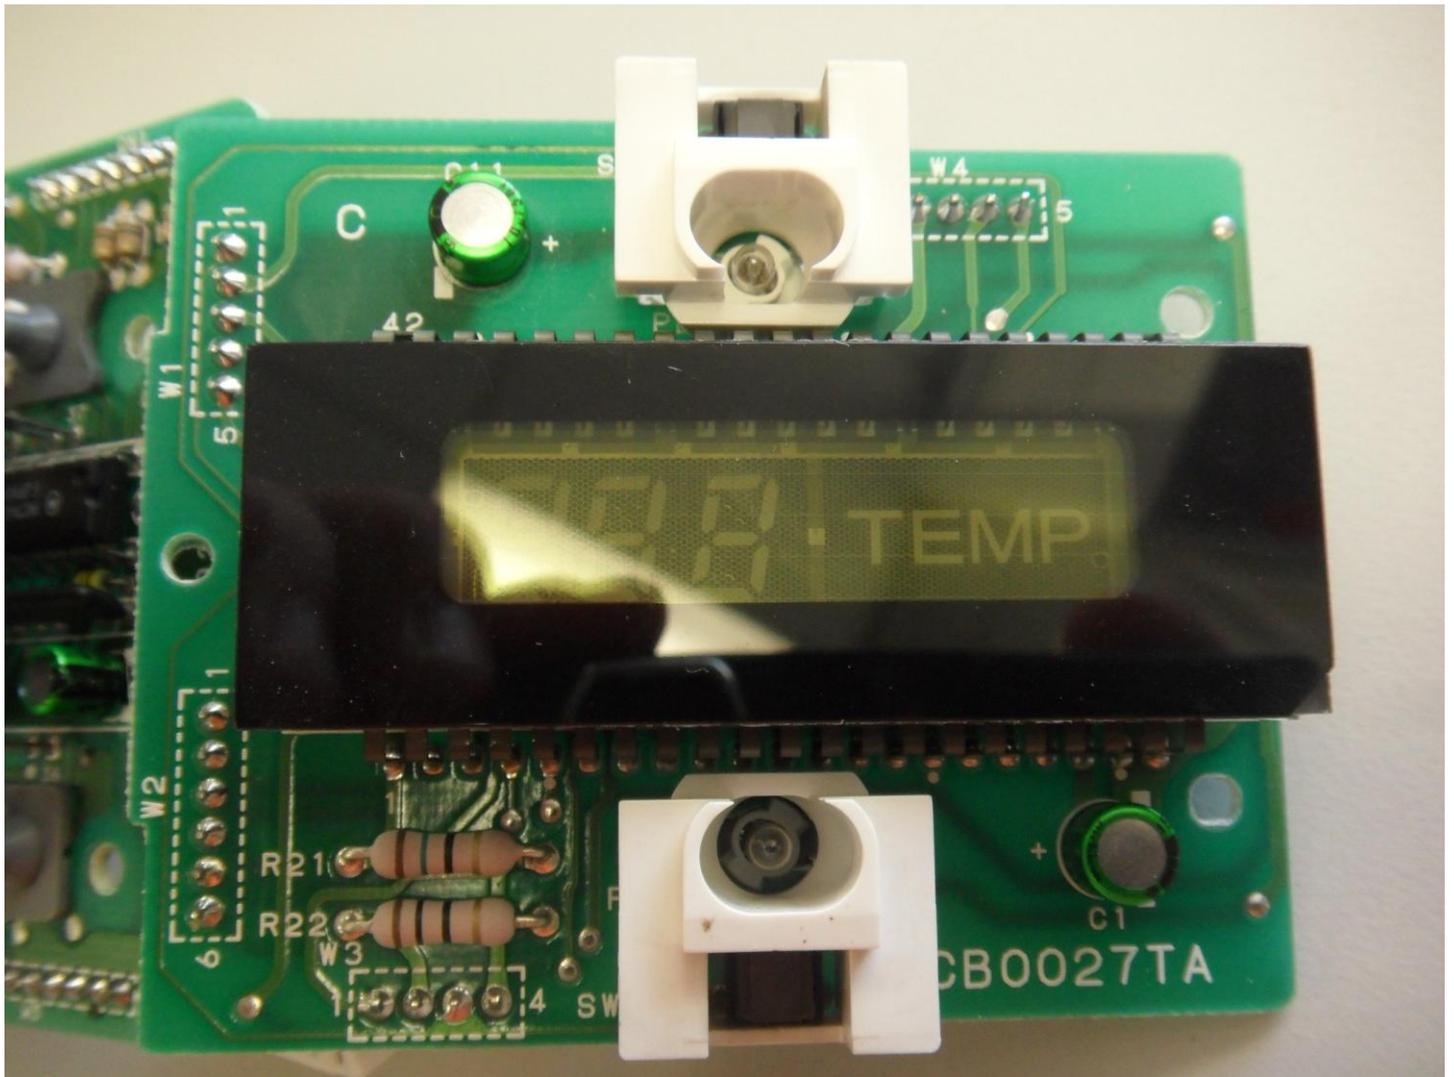
This photo shows the other 2 capacitors that are already 25V rated – these do not need replacing.

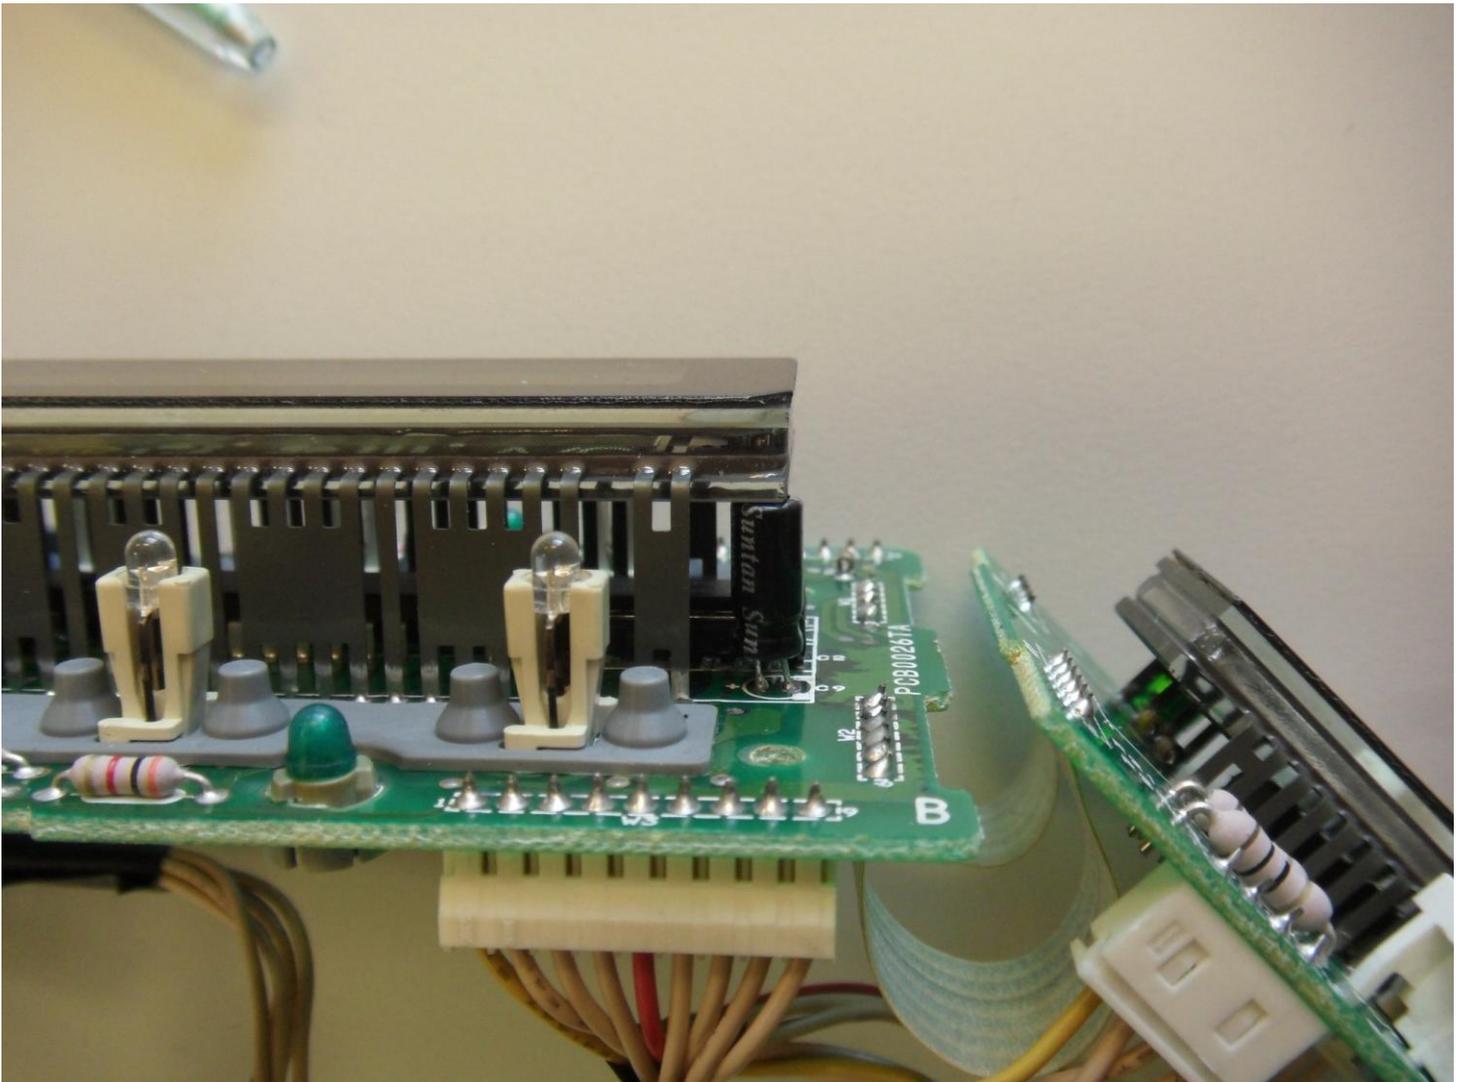
This shows the new 22uF 25V Capacitor in place, I have located the part up against the rear of the display glass in order to gain access to the actual soldering pads from the top side (I used a special microscope at work to check the hole plating and found it damaged by the capacitor liquid corroding the copper and plating in the hole) – hence the initial black colour on the board.

I also soldered the part from the other side of the board.

Locating the capacitor in this way will mean that it will have less chance to swing downwards when located in the correct horizontal position within the dashboard (if they had originally rotated C9 then there would be no chance of part bending while installed into dashboard, again another bad design).

If you cannot reuse the C9 mounting holes then you could connect the positive end to the inductor that sits beside it (small round device with coloured rings along the length) and the other end could be soldered to a ground point, there are plenty of these throughout the board.

If you are going to locate C9 elsewhere remember to 'stick' the capacitor down in order to stop it floating around when the car is moving. N.B:- do not use silicon RTV type adhesive, as while these cure they normally give off acetic acid, which is corrosive for electronic devices, better use a 3M type double-sided foam tape.

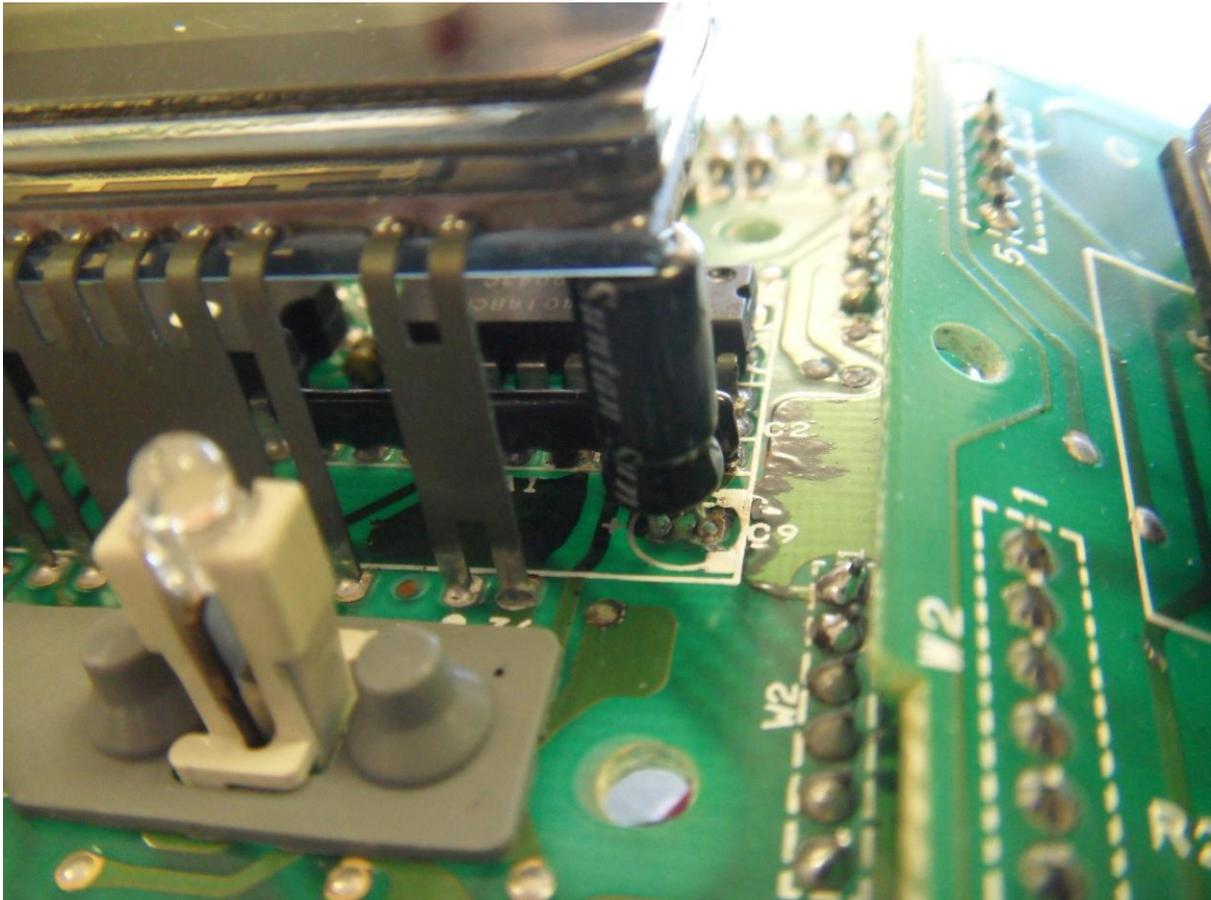
You can see that W2 (row of soldered pads) has also been cleaned and re-soldered.

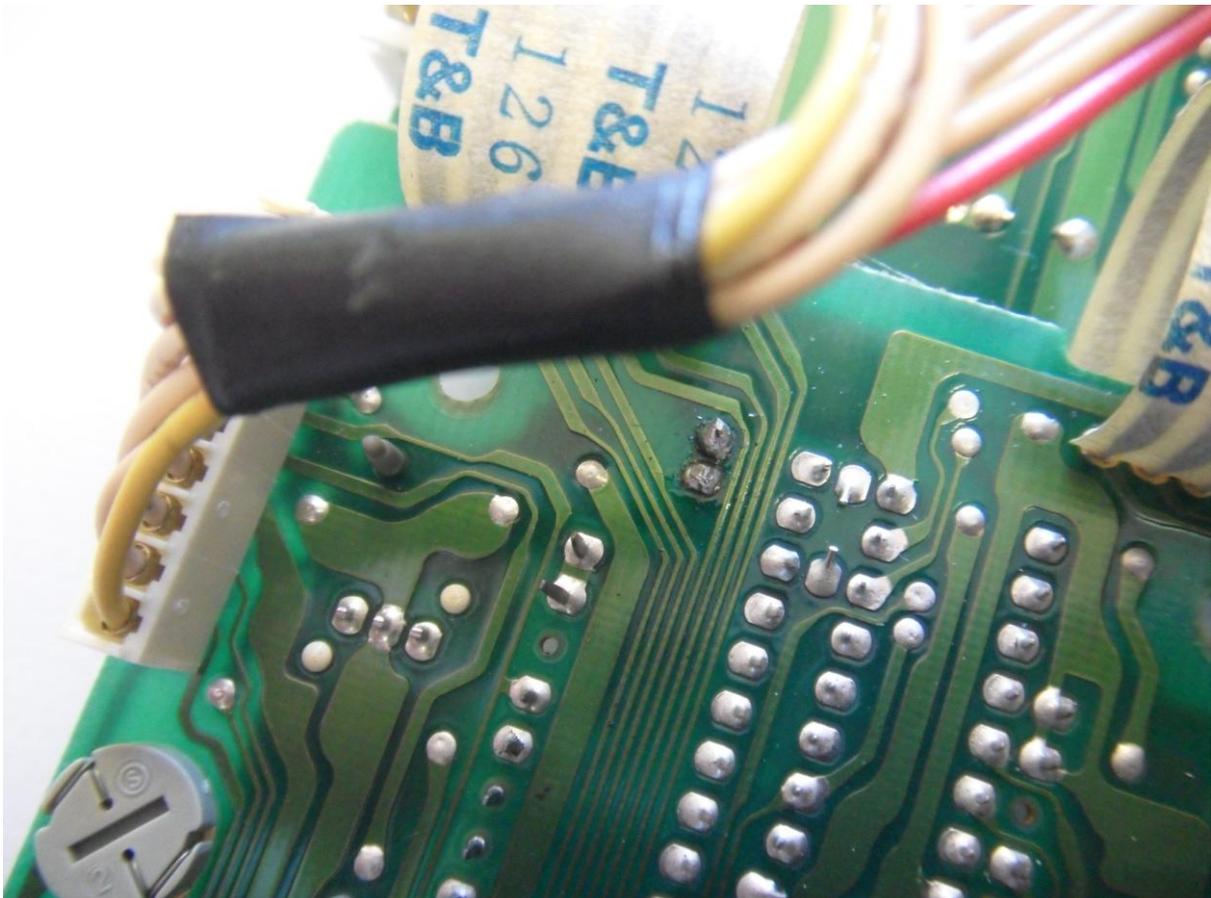
This photo shows the rear of C9 – 2 floating pads, just below the black tape.

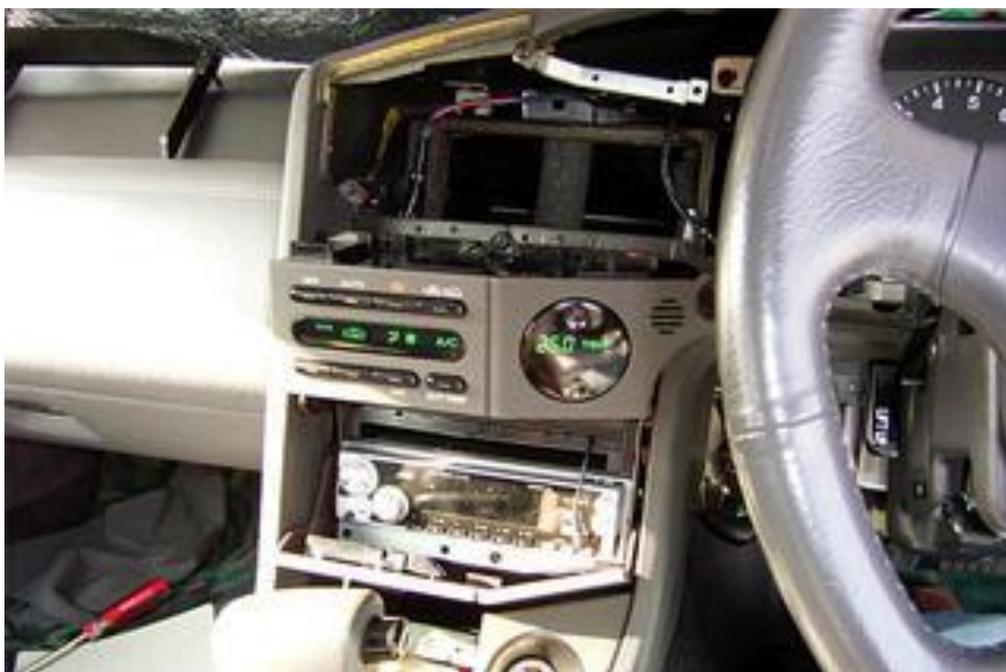
You can now put everything back together but just check the unit runs while the dashboard is still apart (no need to try and connect up the plastic tubing) – just the 2 connectors.
