ECU Bead Crush

The following pictures will assist you with performing the fix in the "Acceleration Control" TSB. (see the [TSB](#) section for instructions)

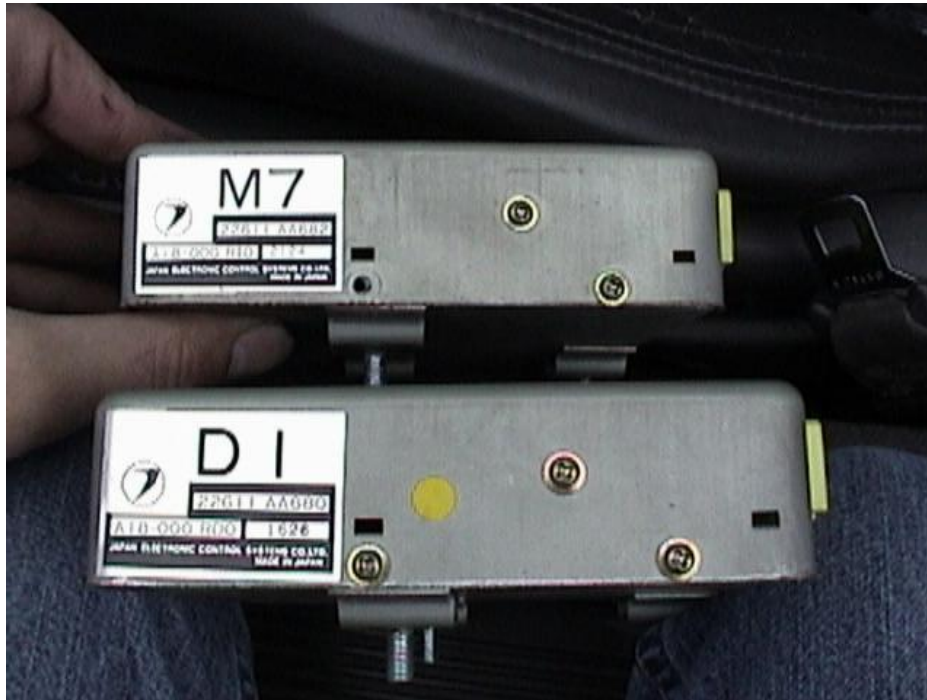
1/92 and 6/91 ECUs

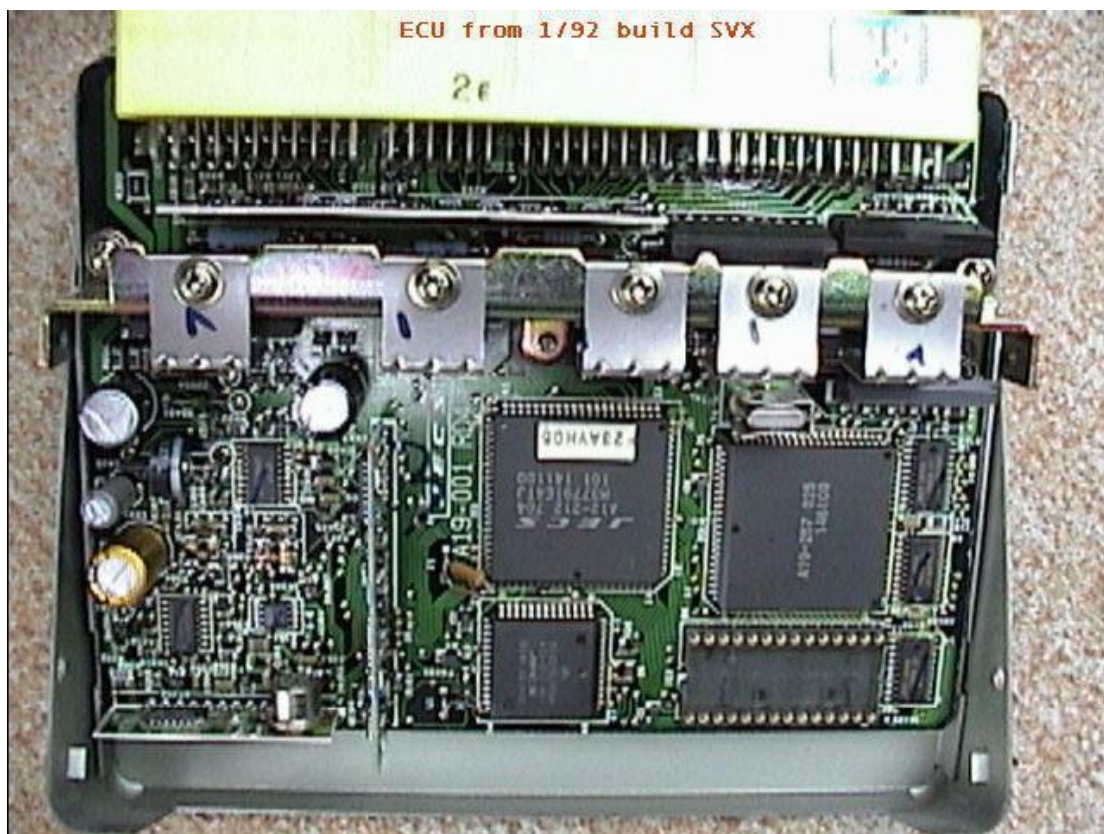
1/92 ECU – With Resistor and Black Noise Suppressor Bead
