## Solving the Drooping Subaru SVX Visor Problem (for less than two dollars)

by Dave Gilbert (LokiDad on the Forum)

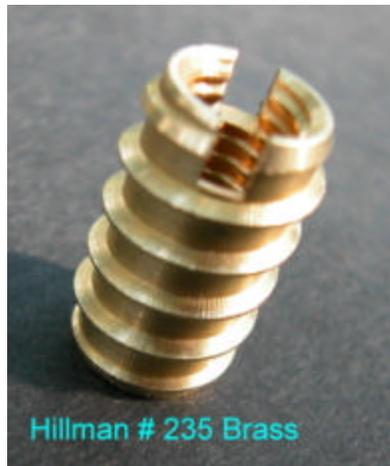
#235 Brass Insert manufactured by Hillman

This was the largest brass insert my particular hardware store carried and is used in furniture repair and furniture making. Hillman seems to sell sets of these kinds of parts to hardware stores for re-sale.

The important thing about this is that it is a DELUXE FIT. The visor shaft that attaches into the roof of your SVX fits so nicely and screws in by itself perfectly – just enough resistance so that the visor works correctly and that it fixes the dreaded droop problem that so many of these visors fail from.

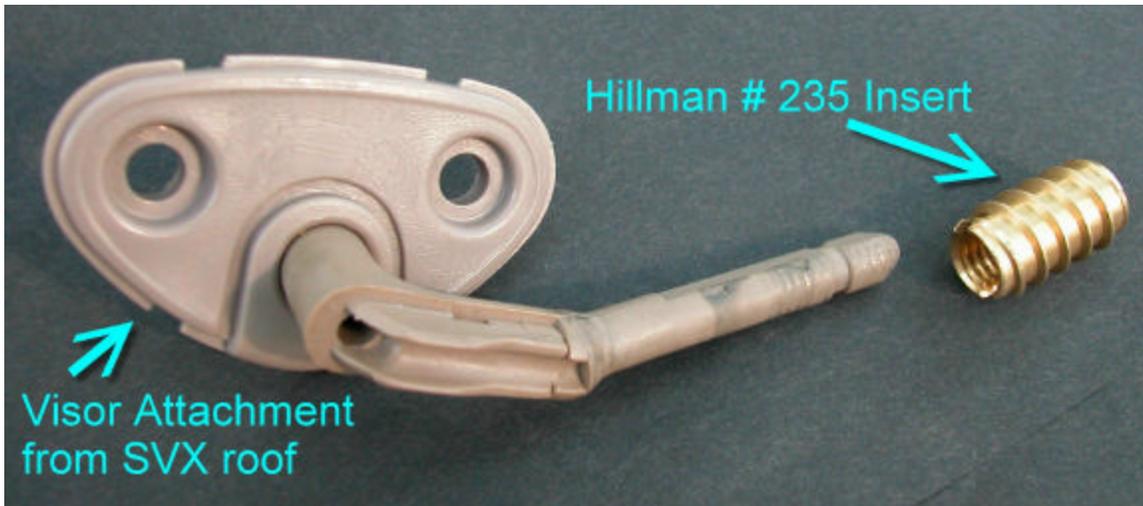
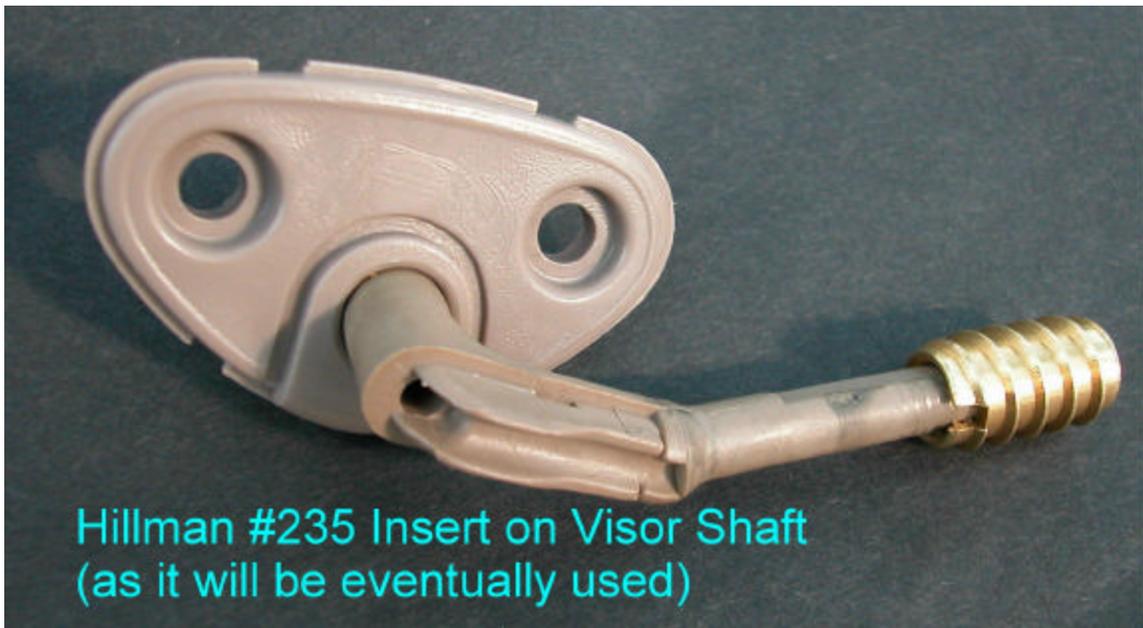
Take a look at the two photos below:

You will find that the Hillman insert fits CUSTOM on the visor shaft: it is tight enough that it almost threads itself, YET it is loose enough that you can adjust it in any position and it will stay put! Perfect for what we need to do, get rid of the dreaded visor DROOP!

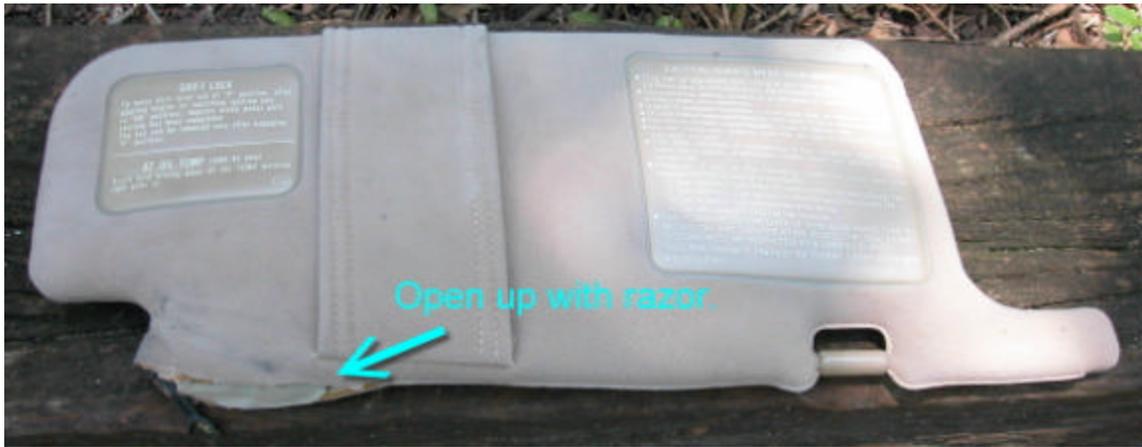
Now the next step is to steady your hand, and with a razor, cut right along the seam of your visor, deep enough to open it up so that you can repair the inside. The next two photos will give you an idea of what you have to do next.

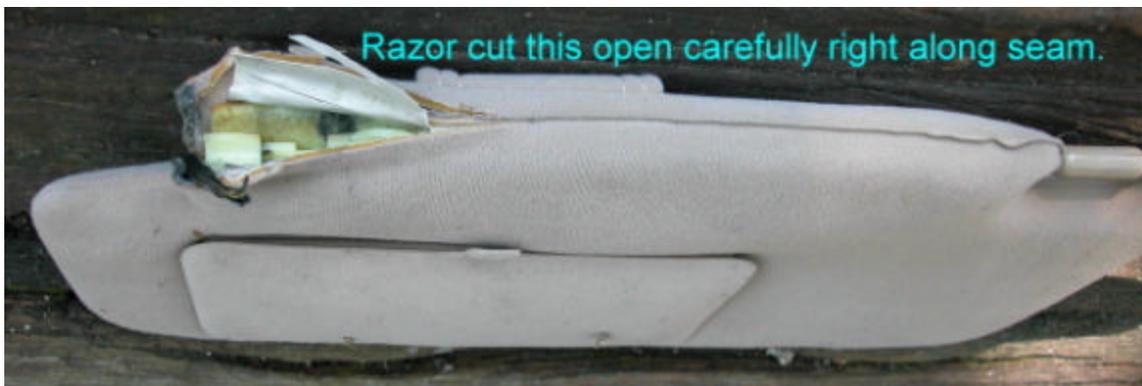
You can see what it looks like opened up in the shot below. You won't need to cut any more than a few inches.

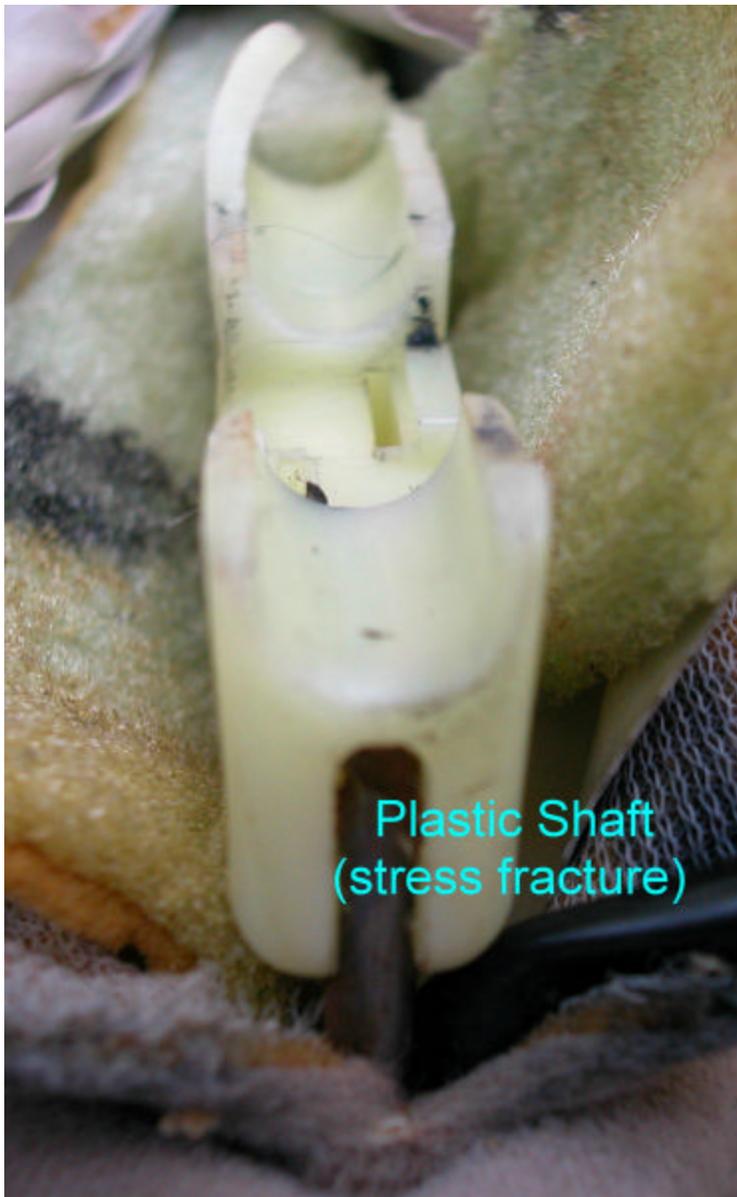
Chances are this plastic shaft is what broke or fractured.

You'll need to see what your particular stress fracture looks like. . . that's what causes the visor to "droop".

Here's what my particular stress fracture looked like:

Yours will be different, but I'll bet it may look much the same. The stress and wear and tear on this part causes the plastic to fail, and therefore the visor droops. That's what has to be repaired!

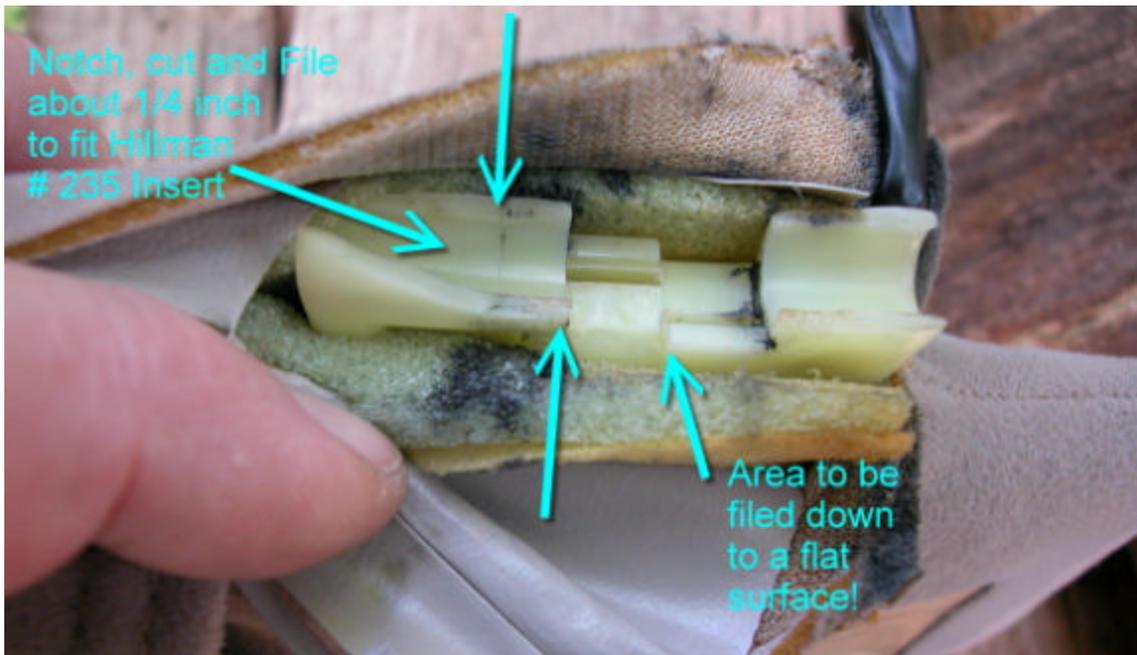
But we have to do a few things first, and to do that, I'll show you a side or profile view of the whole work area and what needs to be done in the next photo.

You can see from the shot above that the top of the plastic shaft basically sheared off or broke from age and from being adjusted. The area that we have to work with doesn't fit the insert just yet. There's a little ridge that had some metal clips in it that present a problem, and the overall opening is not long enough for the Hillman #235 brass insert.

You will find that the notch that is already in the plastic does not have a flat bottom, plus the notch isn't long enough for the Hillman #235 brass insert to fit properly. (To see this once again, GO BACK to the photo before the last two and take a good look at it again)

We will have to clip off about a quarter of an inch from the shaft to make the insert fit length-wise, and we have to file it all down FLAT so that the insert rests nicely in place. I used a metal file and it gave me a nice flat surface.

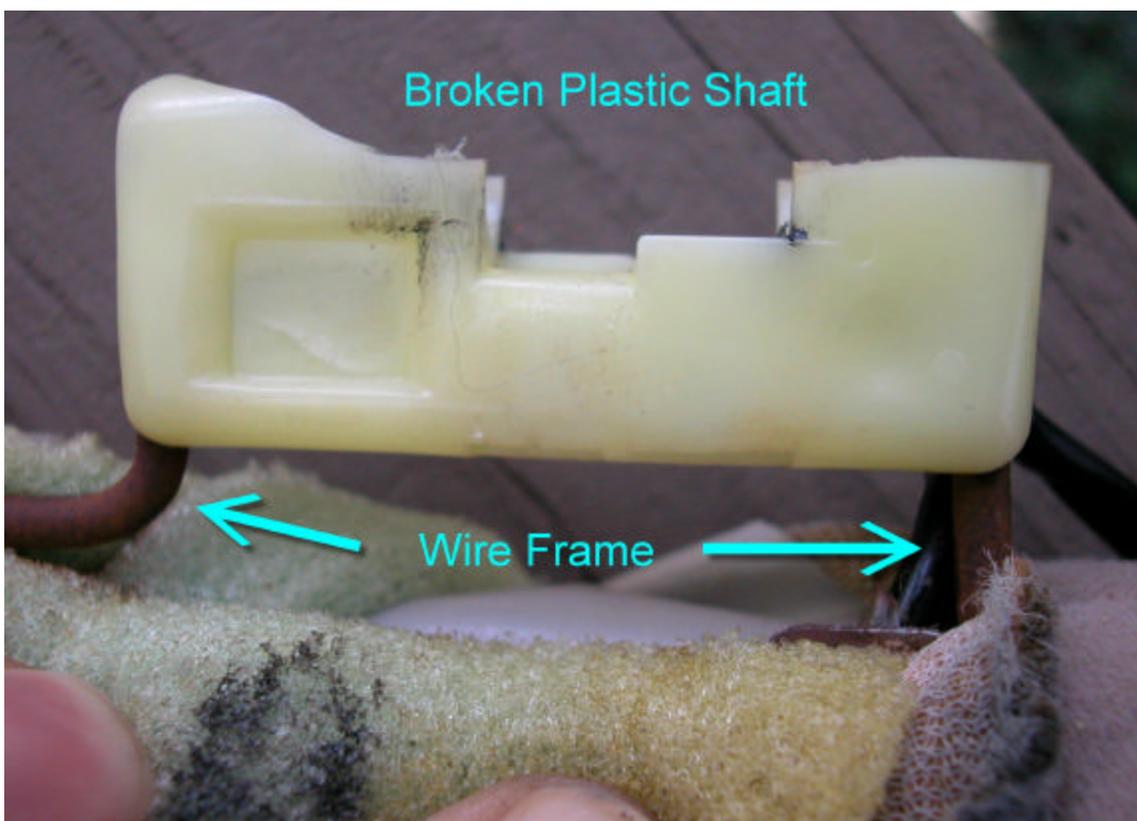
Luckily the plastic shaft is held in place by a wire frame (see below) that goes all around the visor. This is what we'll be able to use to our advantage with the electrical ties later.

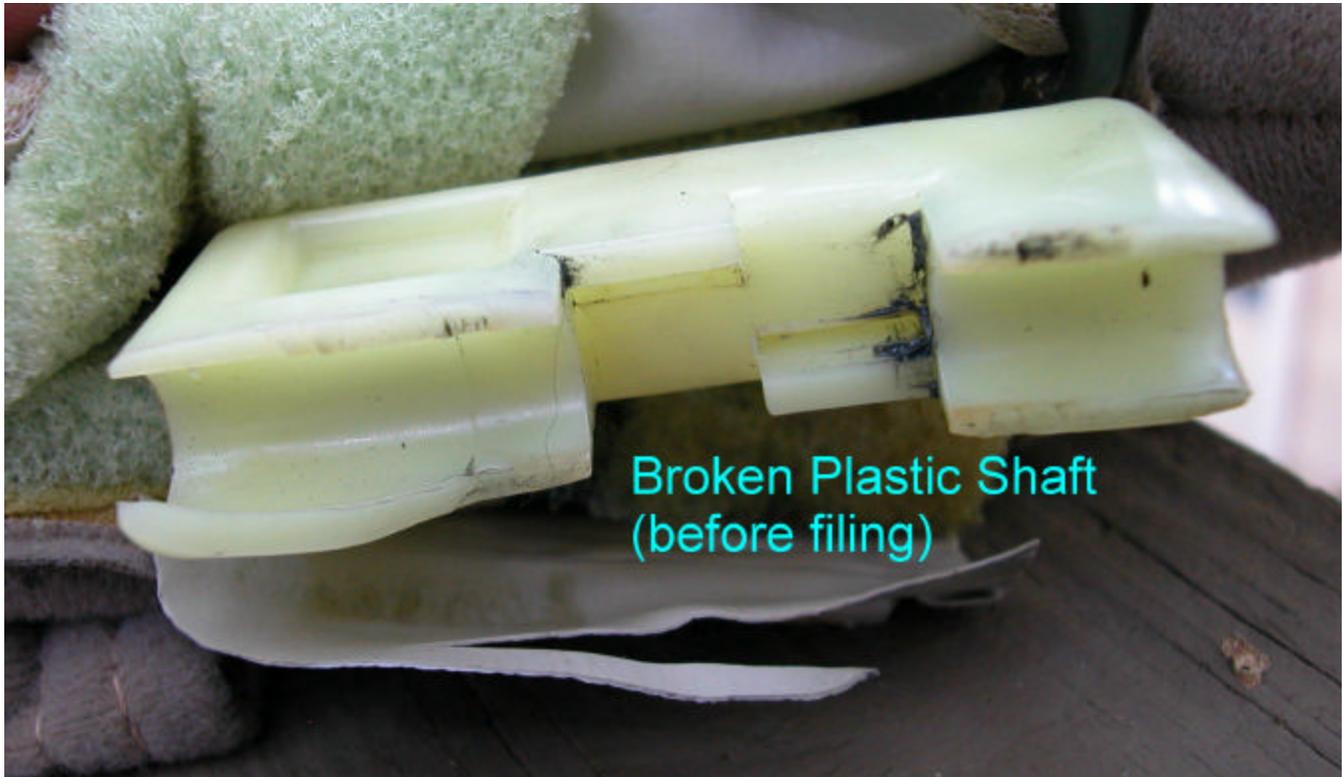
Here's another view:

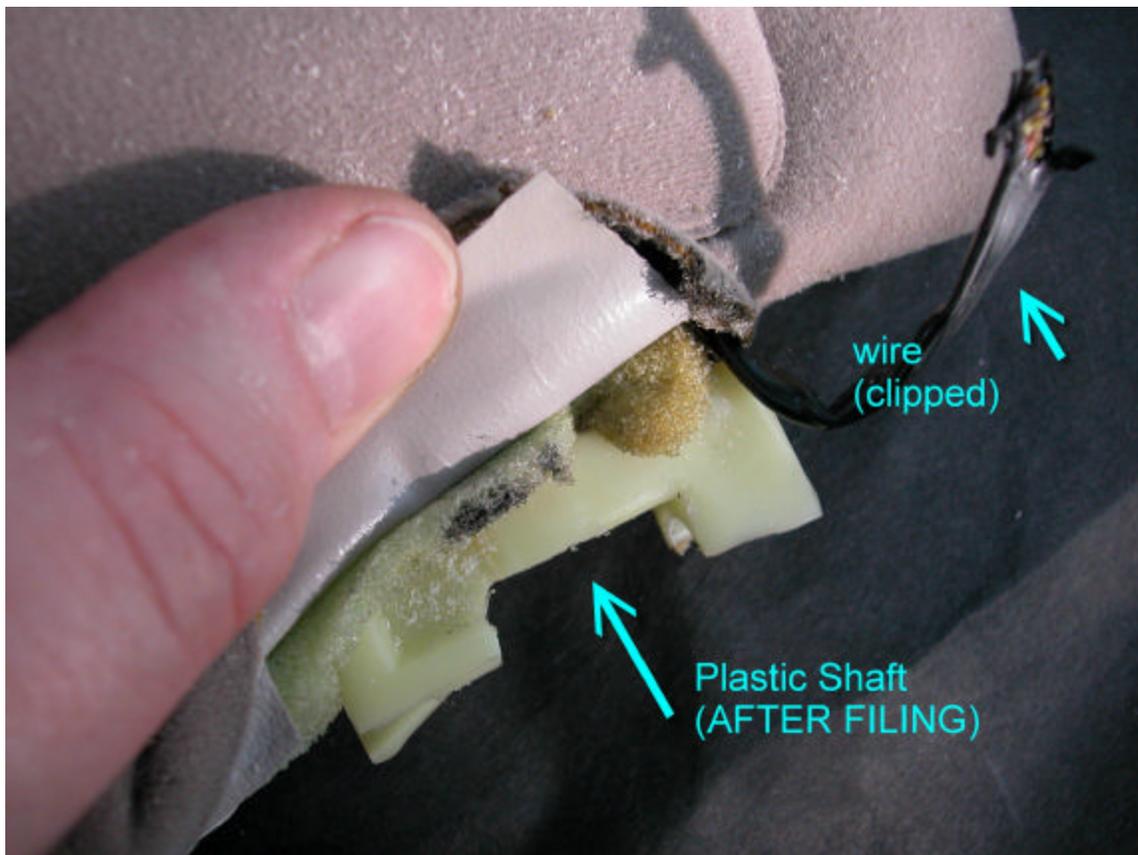
Here's what it looks like when that has been accomplished:

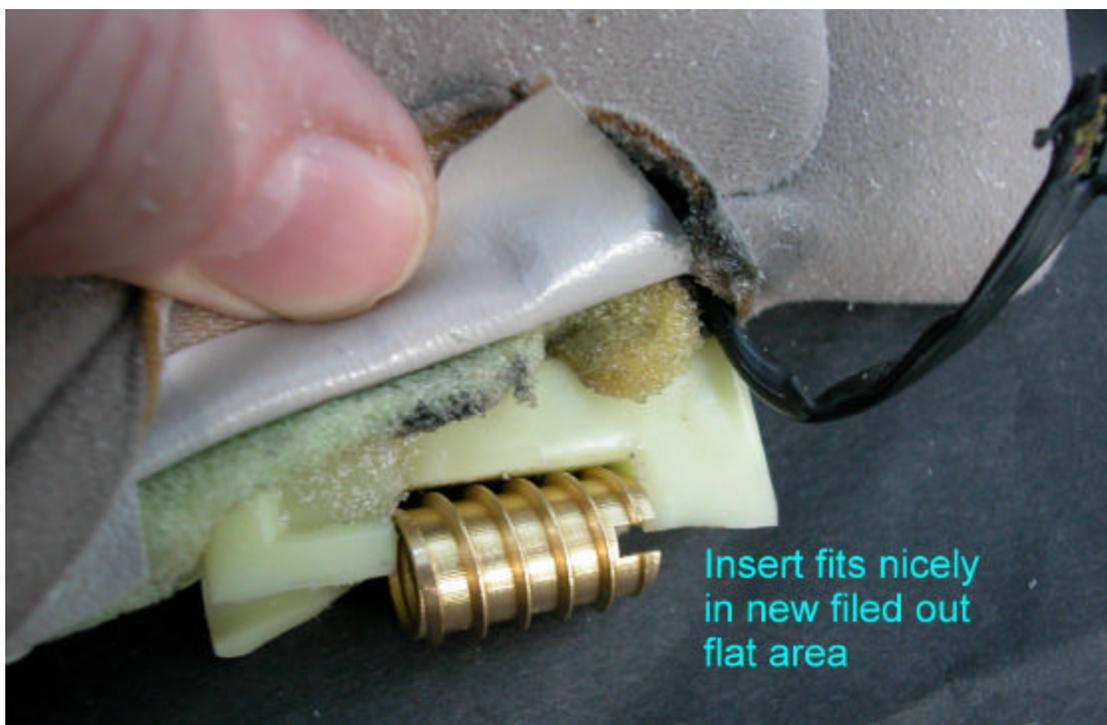
Now we can add the insert, tie it in with electrical ties, and epoxy it in.

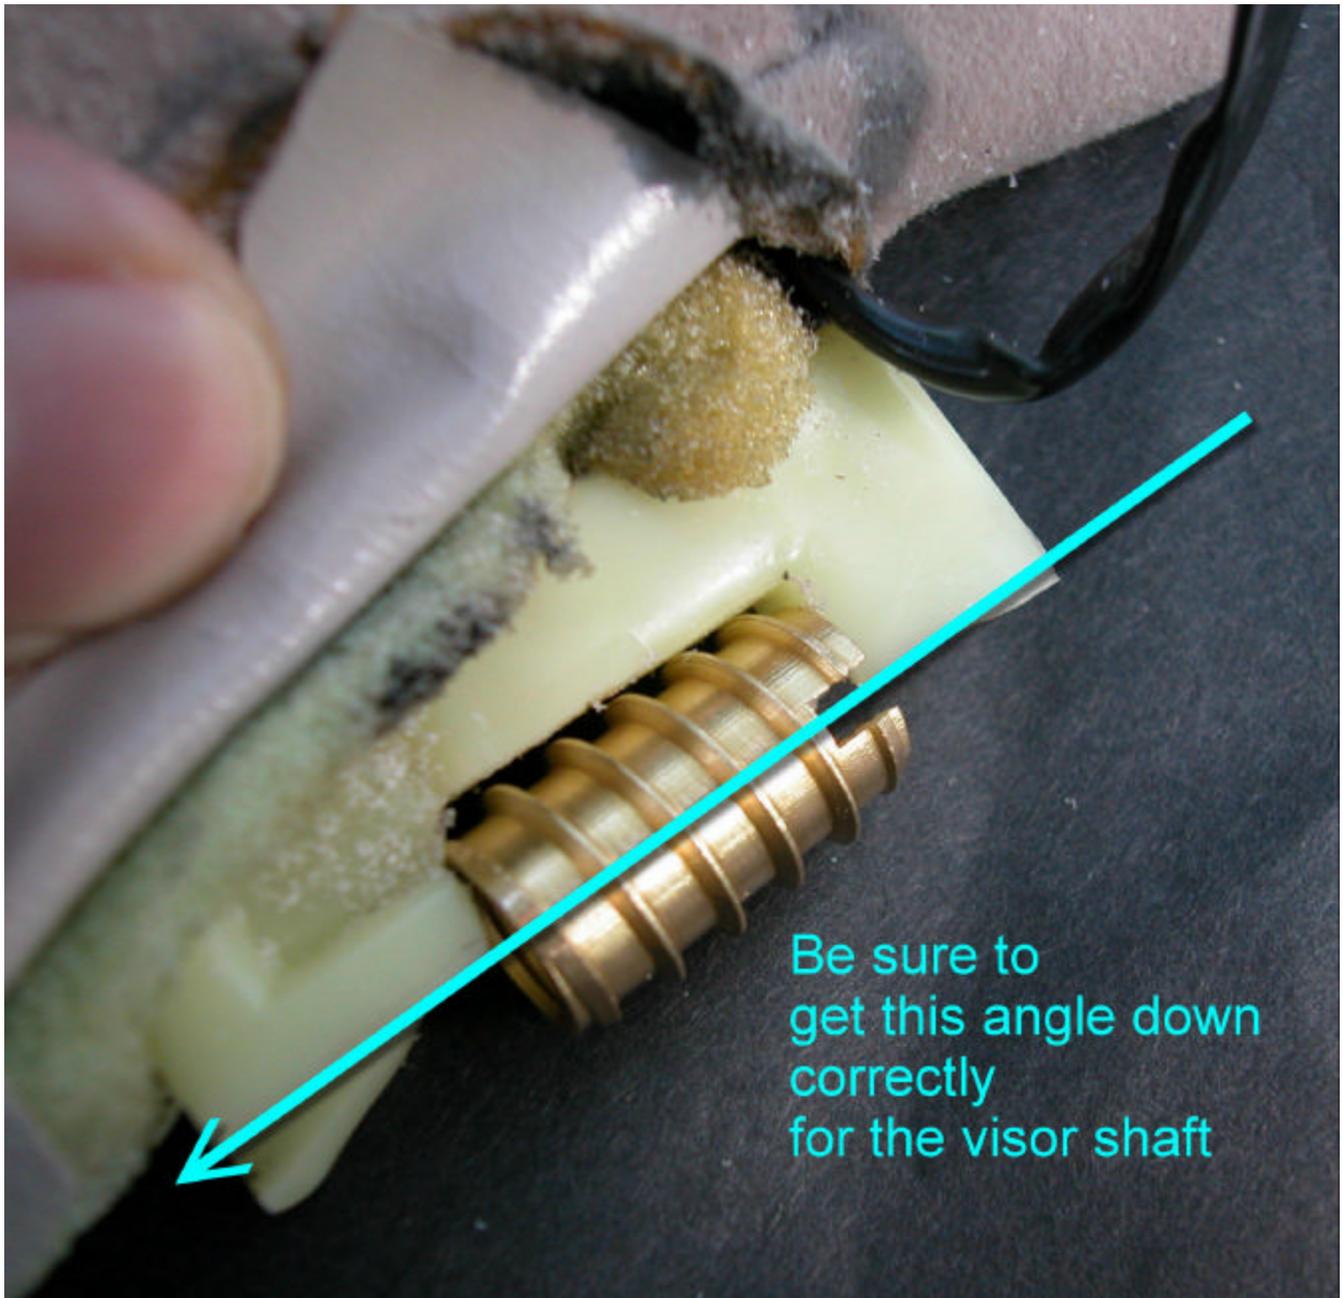
Before you glue everything in, you'll want to make sure that the shaft of the insert has the proper angle to what USED to be there in plastic form before it broke. So be sure to check the angles, and DON'T get any epoxy into the interior of the insert, or you'll wreck the threading area and the fit! Here's a shot of the angle that is critical:

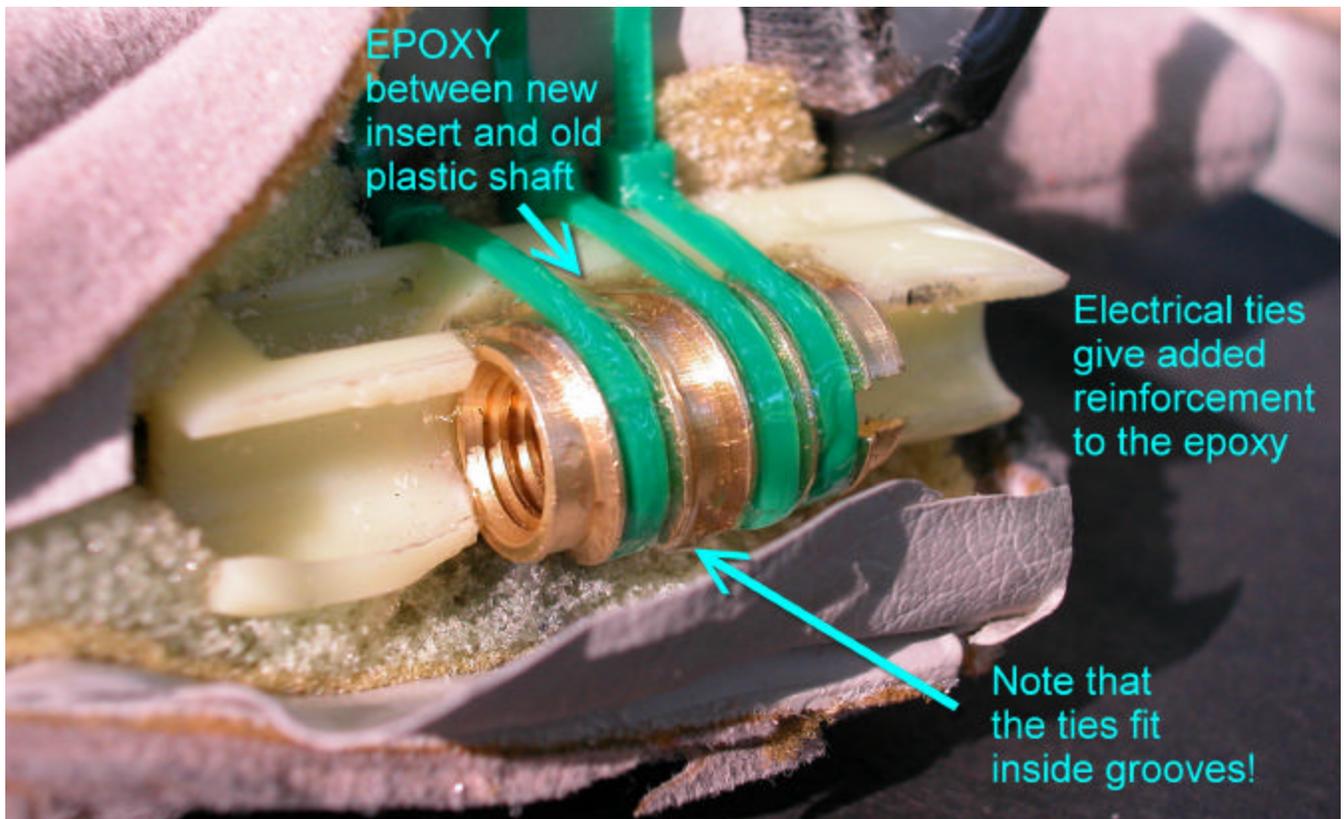
Here's a shot of the insert glued and tied into place:

Now that everything fits, we can add the electrical ties, epoxy it all in with the 5 minute epoxy, and then re-stitch or re-glue the visor skin back to the way it was originally.

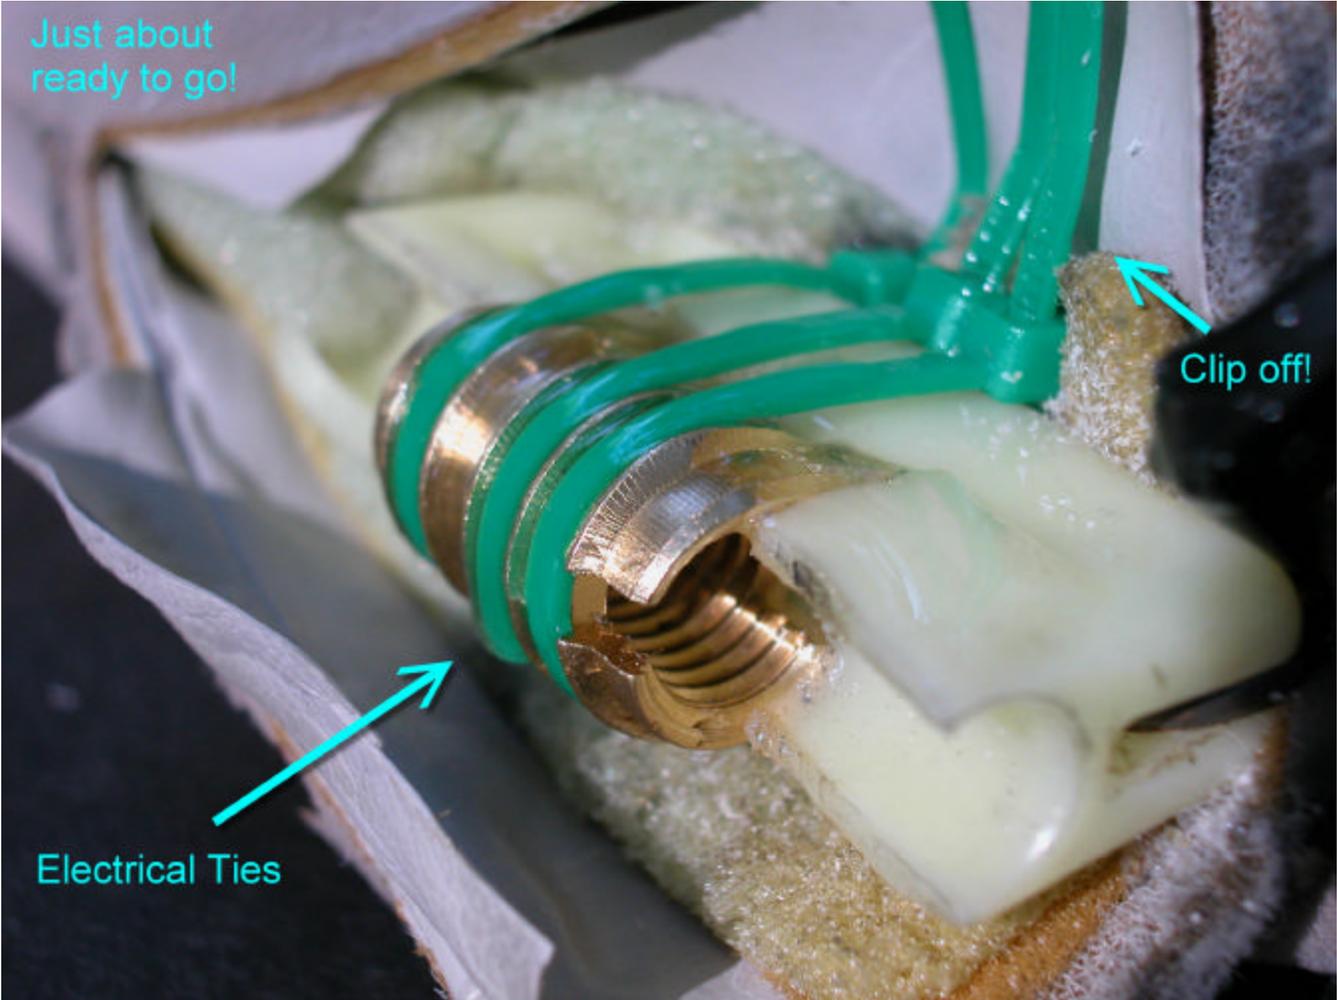
And here's another angle of the same thing just for good measure:

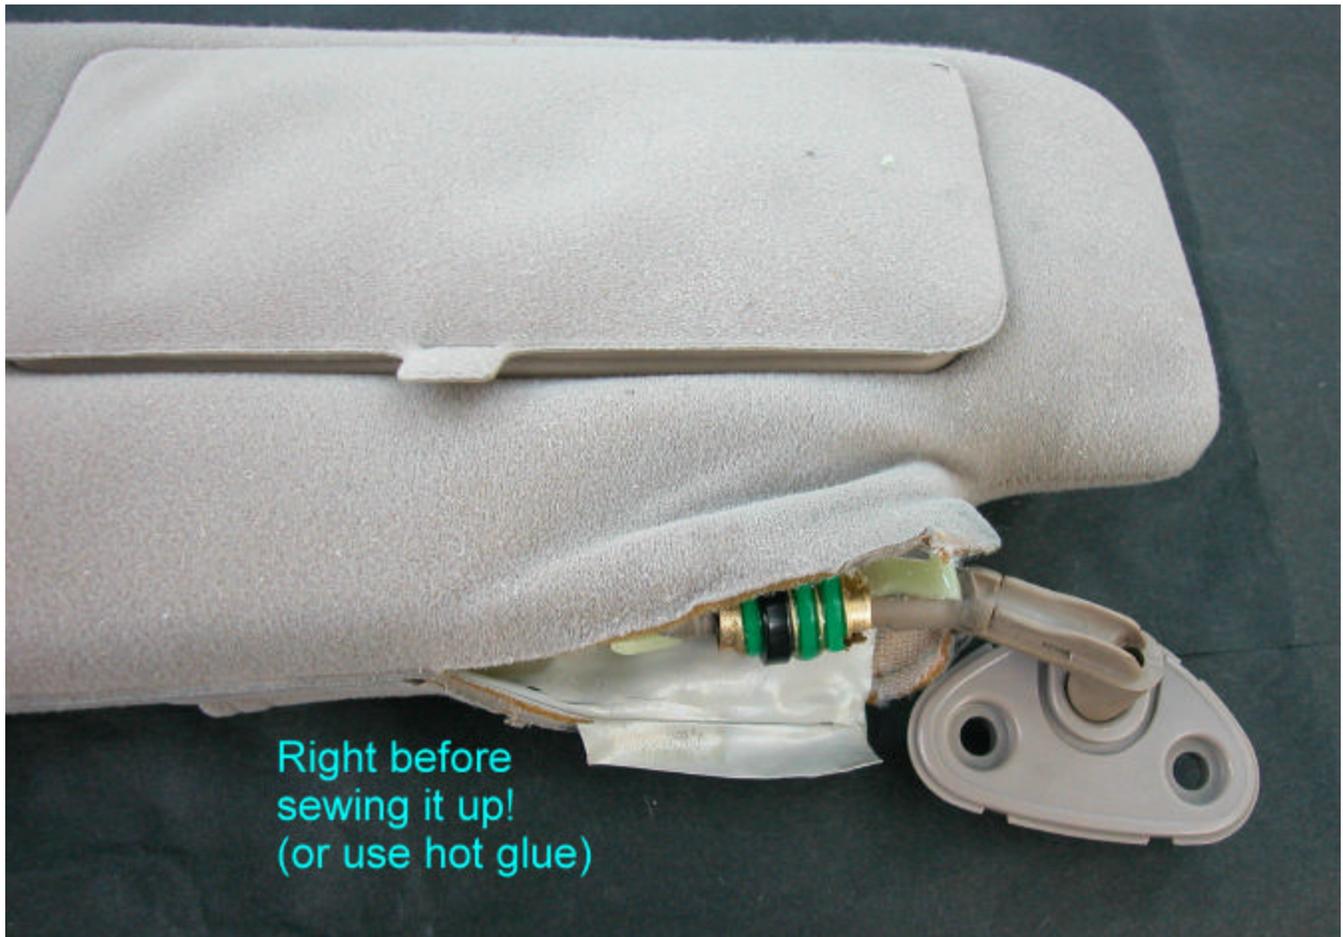
Now just to stitch it up. But before doing so, you can see I couldn't resist the urge to put in one more black electrical tie just for good measure.

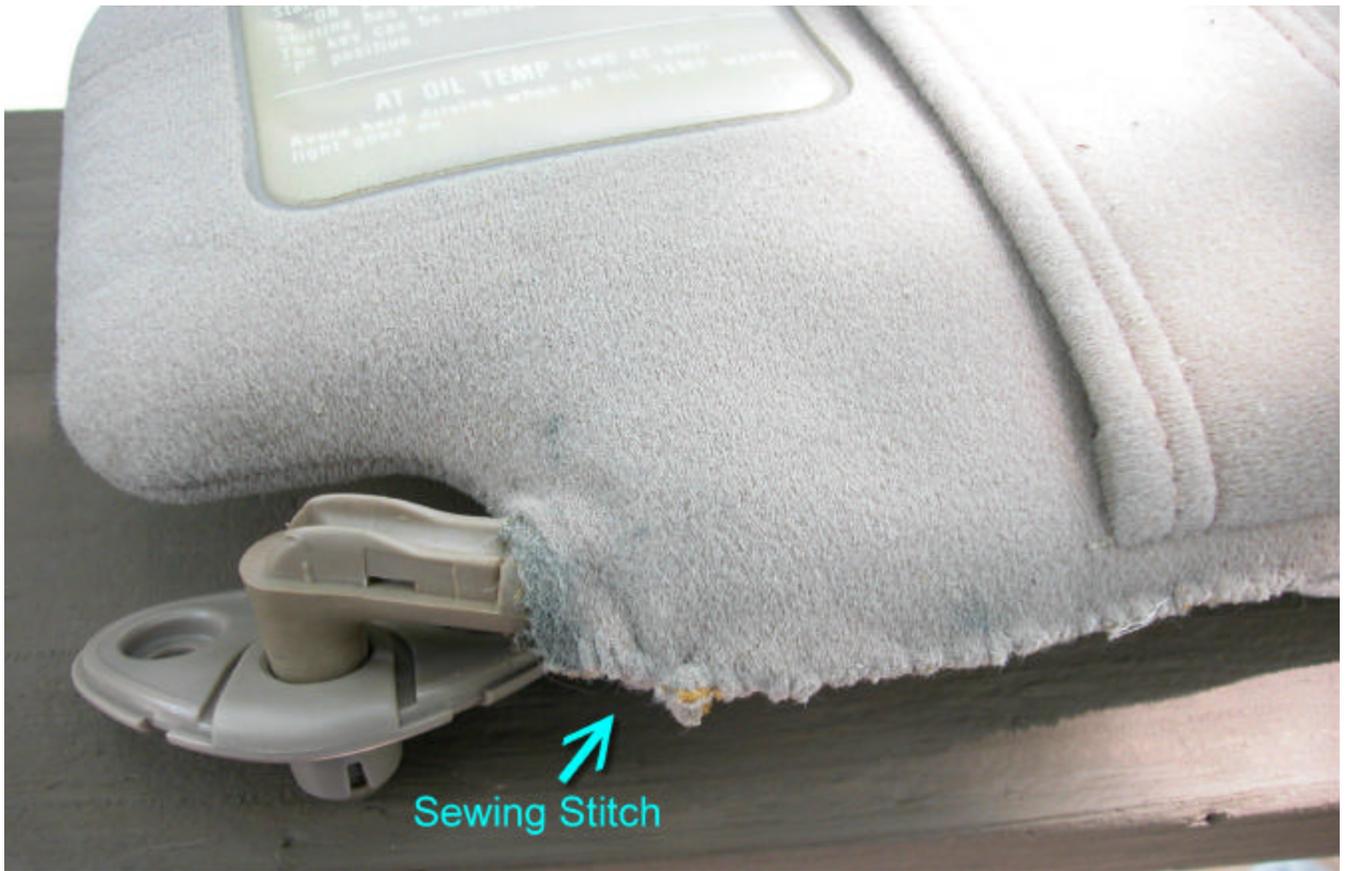
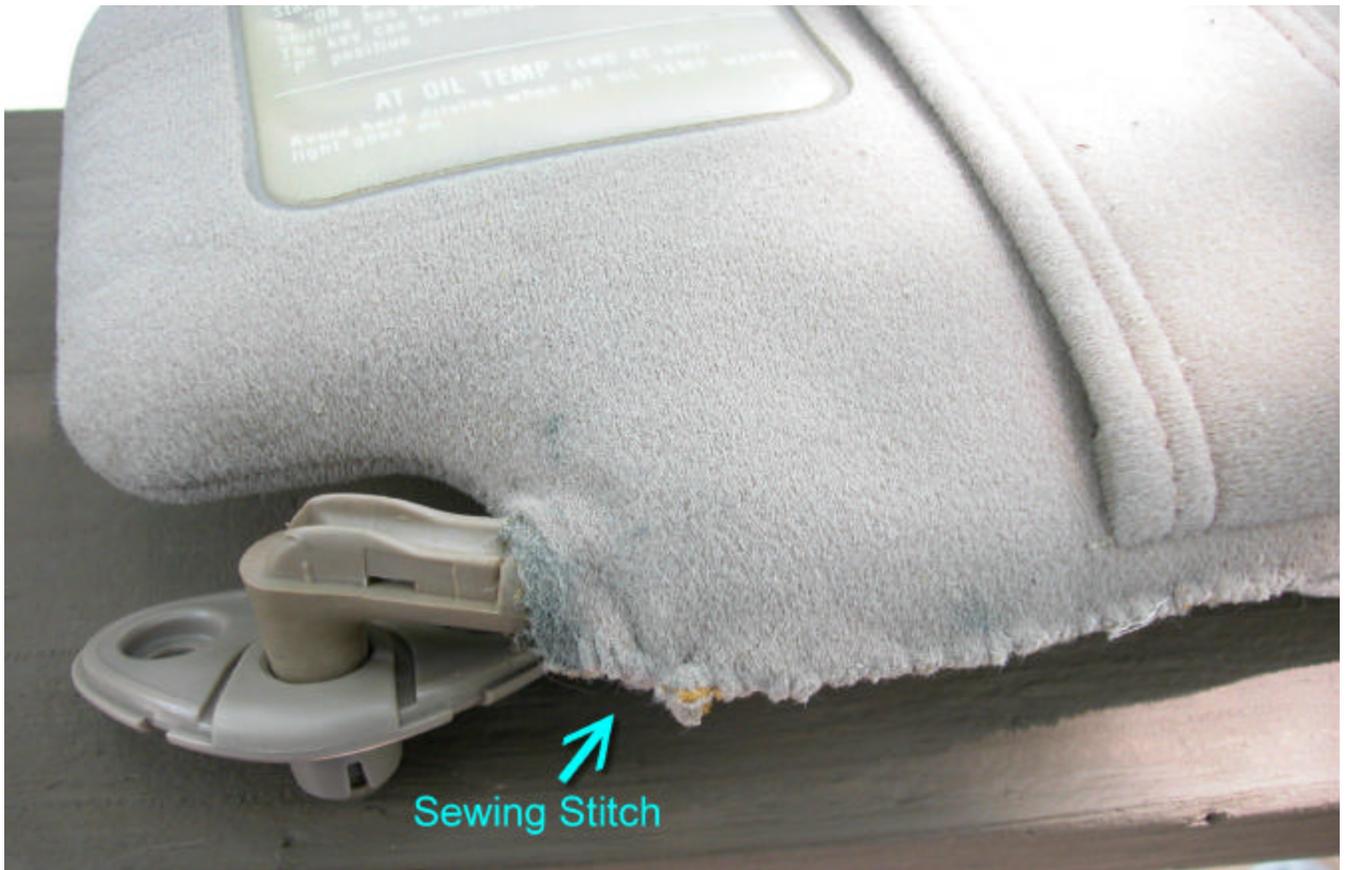
Next page is the finished project. No droop for a buck and a quarter! Or at least under five bucks.

I decided to sew mine shut, even though I'm obviously not the best at sewing. Nonetheless, this seam will go against the outside window and when parked in its normal position, and as my Grandpa used to say, "A man on a slow horse wouldn't see it".
