Transmission Resistor Replacement

Pictures and directions by **sperry** and edited by **ensteele**

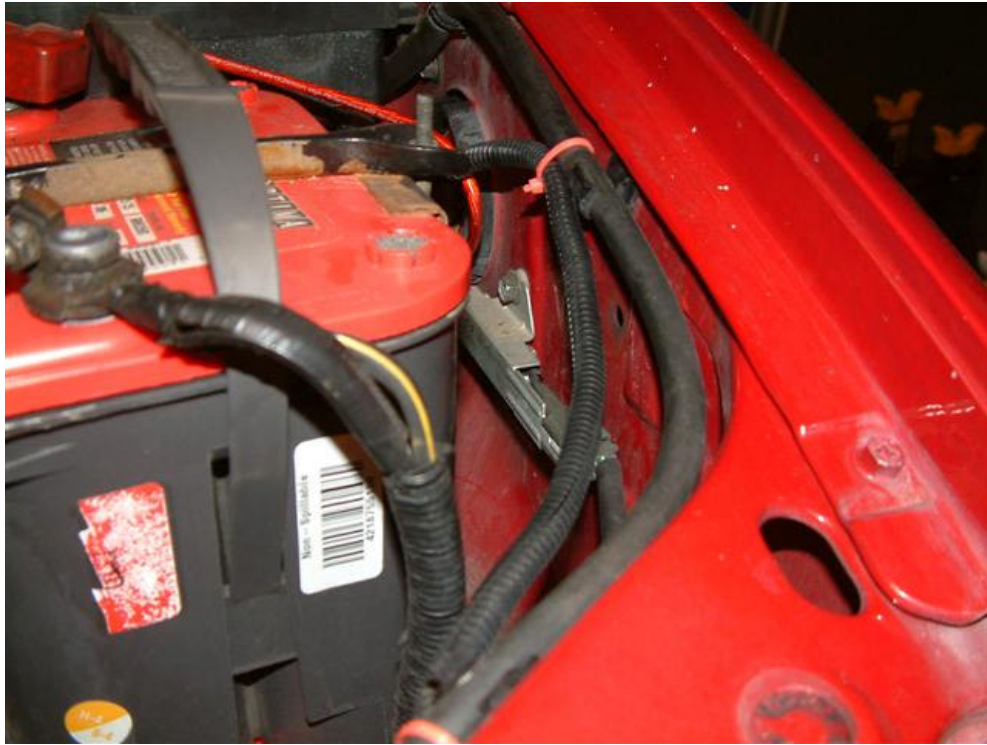
This is how the transmission resistor can be replaced for a total cost of about \$2.00. The resistor is found mounted in the engine bay along side of the battery.

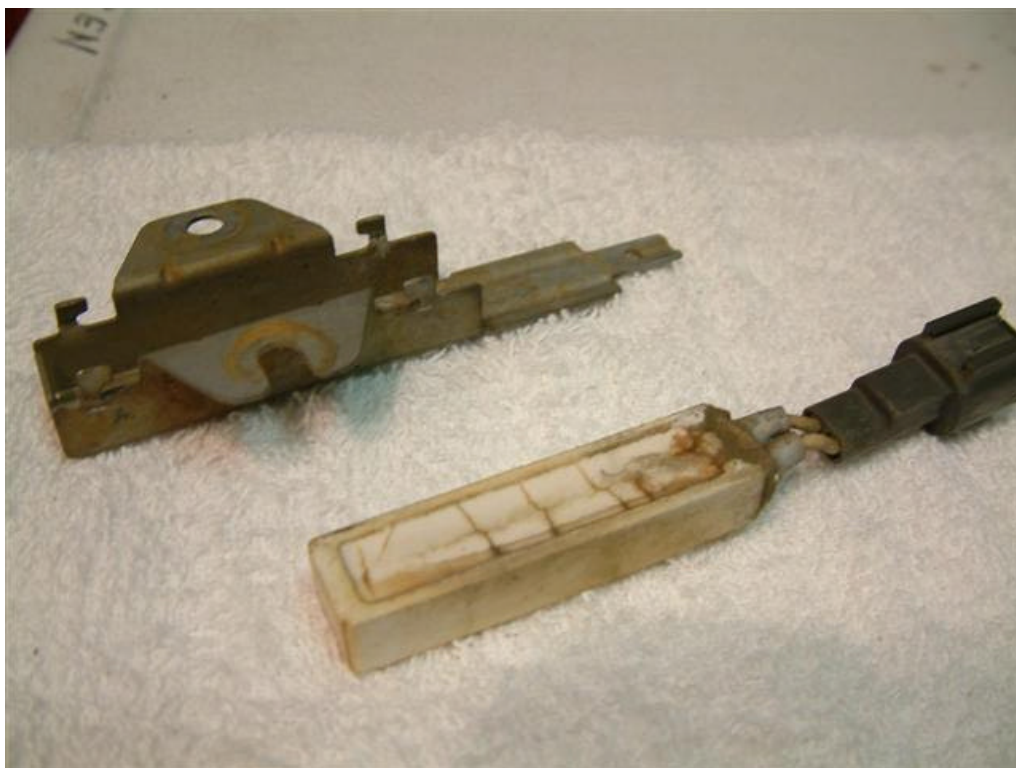
The next picture shows the resistor out of the metal bracket.

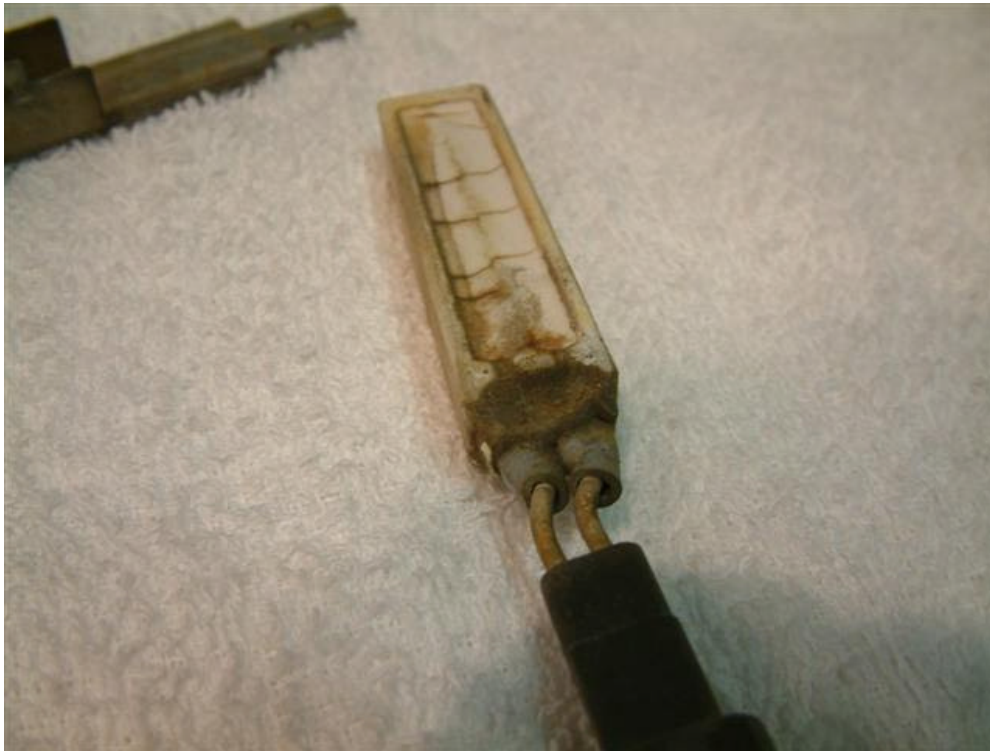
You can see that the old resistor is shows extreme wear. When this resistor was checked with a meter, it showed an open connection!

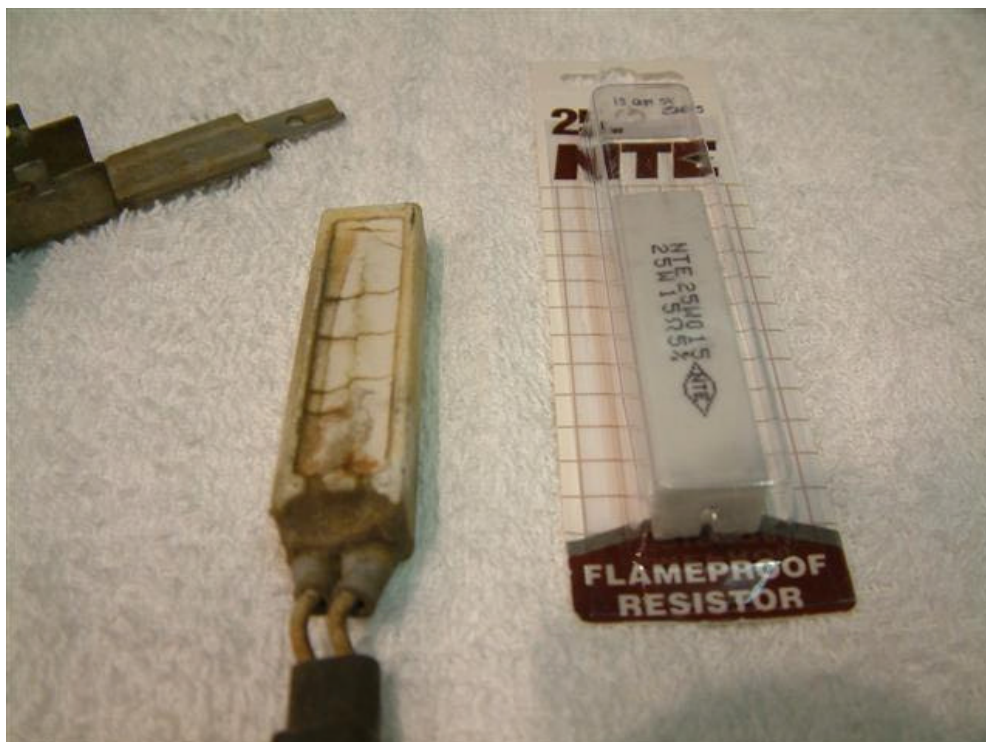
Here's the old resistor next to the 25W - 150hm replacement with the bracket off to the left side.

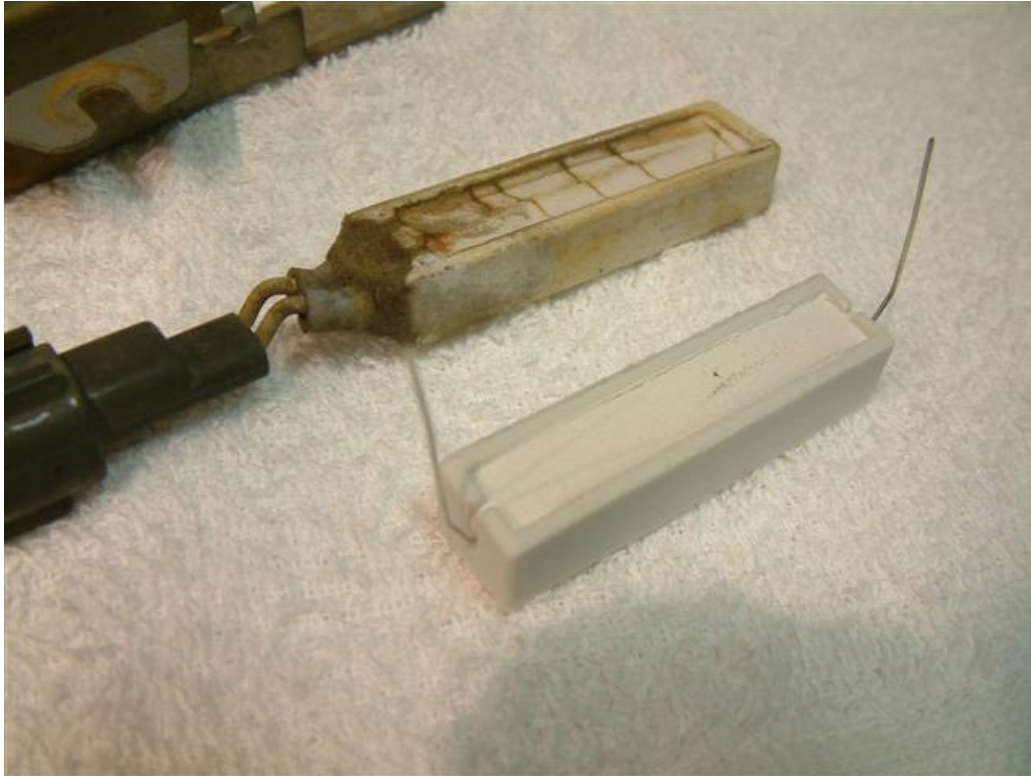
Here is another picture of the old and new resistor. Note the different types of wires attached to both.
